# Allstate Home Inspections, Inc.

**Property**  
12345 Fisher Island Drive  
Bayside Village  
Miami, Florida 33109

**Report ID:**  
151115-1WF

**Inspection Date:**  
11/15/2015

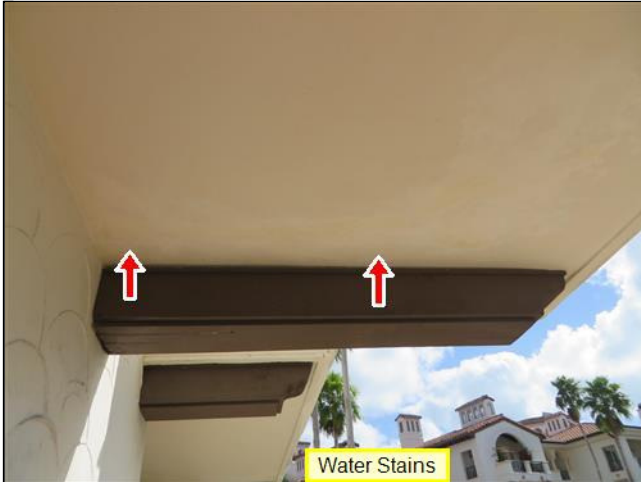
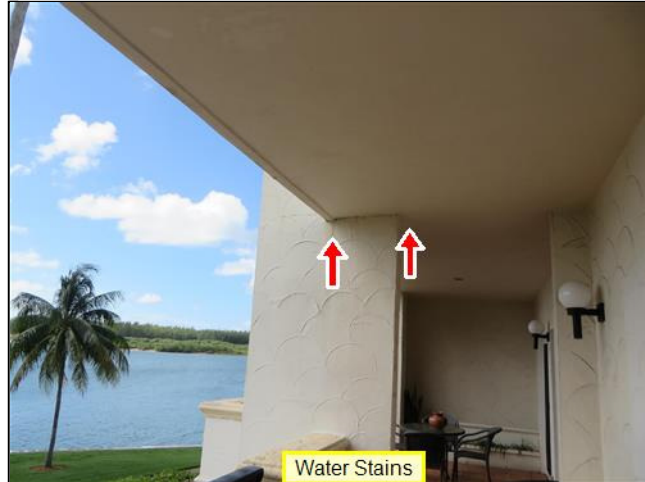
**1.0.B** Water stains were observed on the rear balcony ceiling (see photos 1 & 2), areas were tested for moisture with moisture monitor, **NO MOISTURE WAS DETECTED** at time of inspection. These stains are most likely caused by an old leak from the balcony above which appears to have been repaired. **We recommend that the buyer continue to monitor the stained area or areas and contact a licensed waterproofing contractor and/or the condominium association maintenance department if a stain appears to change color and/or a visible leak is observed.**

Water stains were observed on the rear balcony ceiling (see photos 1 & 2), areas were tested for moisture with moisture monitor, **NO MOISTURE WAS DETECTED** at time of inspection. These stains are most likely caused by an old leak from the balcony above which appears to have been repaired. **We recommend that the buyer continue to monitor the stained area or areas and contact a licensed waterproofing contractor and/or the condominium association maintenance department if a stain appears to change color and/or a visible leak is observed.**

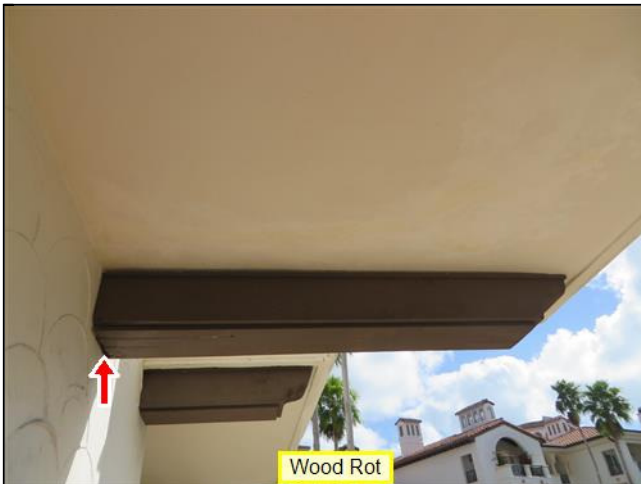
1.0.B Item 3(Picture)

Wood rot was observed at the decorative beam on the rear balcony's ceiling (see photo 3), repair is needed. We recommend contacting the condominium association maintenance department for further evaluation and all needed repair.

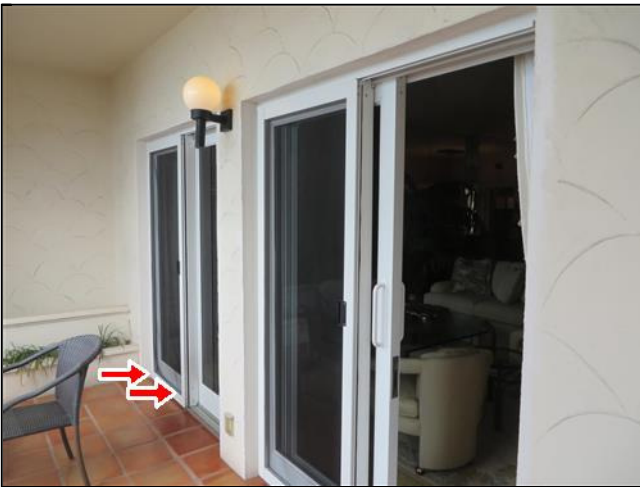
2.0.B Item 1(Picture)

**2.0.B** Living room's screen door is off it's track (see photo), repair, adjustment and lubrication is recommended. We recommend contacting a licensed door contractor for further evaluation and all needed repair.

Living room's screen door is off it's track (see photo), repair, adjustment and lubrication is recommended. We recommend contacting a licensed door contractor for further evaluation and all needed repair.

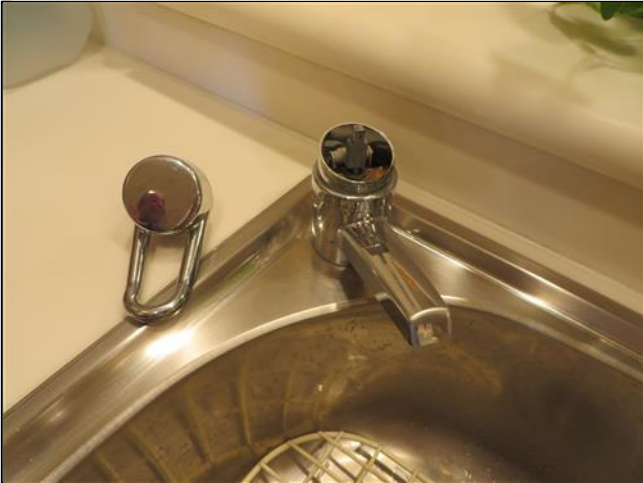
3.5 Item 1(Picture)

3.5 Insta-hot control handle was loose (see photo), repair is needed. We recommend contacting a licensed plumber for further evaluation and all needed repair.

Insta-hot control handle was loose (see photo), repair is needed. We recommend contacting a licensed plumber for further evaluation and all needed repair.

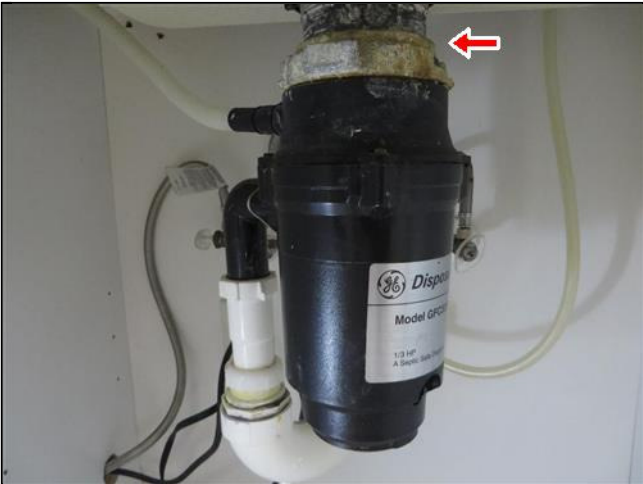
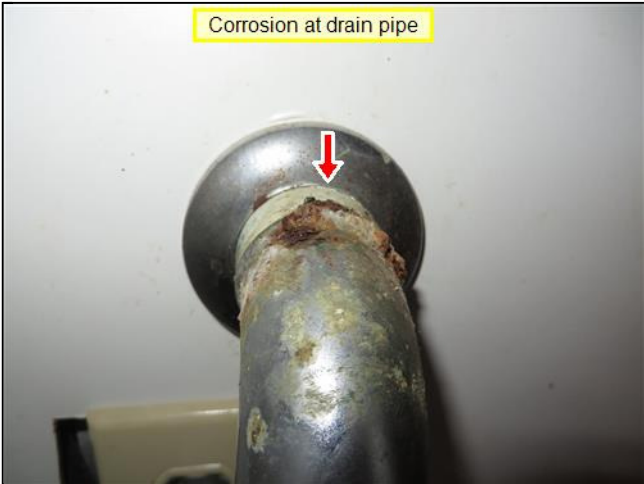
3.6 Note: Corrosion was observed at the garbage disposer and a drain pipe under the kitchen sink (see photos). No leaks were observed at time of inspection. Due to the age and condition of this garbage disposer, repair or replacement is recommend in the near future to prevent leaks. Contact a licensed plumber for further evaluation and repair if needed.

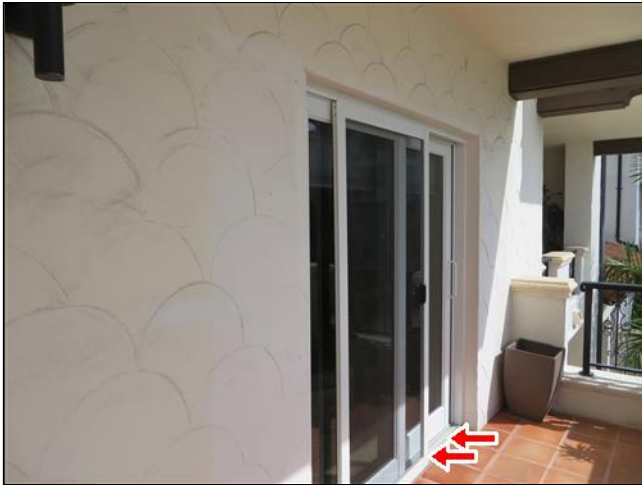
4.0.A Item 1(Picture)

**4.0.A** Master bedroom's screen door is off it's track (see photo), repair, adjustment and lubrication is recommended. We recommend contacting a licensed door contractor or a qualified handyman for further evaluation and all needed repair.

Master bedroom's screen door is off it's track (see photo), repair, adjustment and lubrication is recommended. We recommend contacting a licensed door contractor or a qualified handyman for further evaluation and all needed repair.

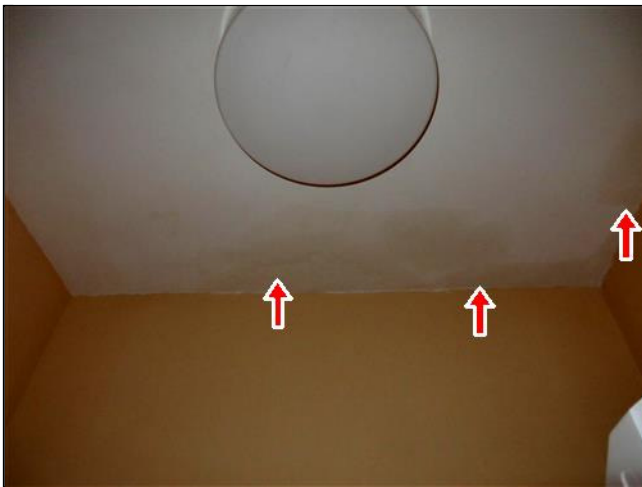
4.2.A Item 1(Picture)

**4.2.A** Water stains were observed on the ceiling in the master bedroom hallway closet (see photo), area was tested for moisture with moisture monitor, **no moisture was detected** at time of inspection. These stains are most likely caused by an old leak from unit above which appears to have been repaired. We recommend contacting the Condominium Association Maintenance Department for further evaluation and repair if needed. **We recommend that the buyer continue to monitor the stained area or areas and contact the condominium association maintenance department if the stain appears to change color and/or a visible leak is observed.**

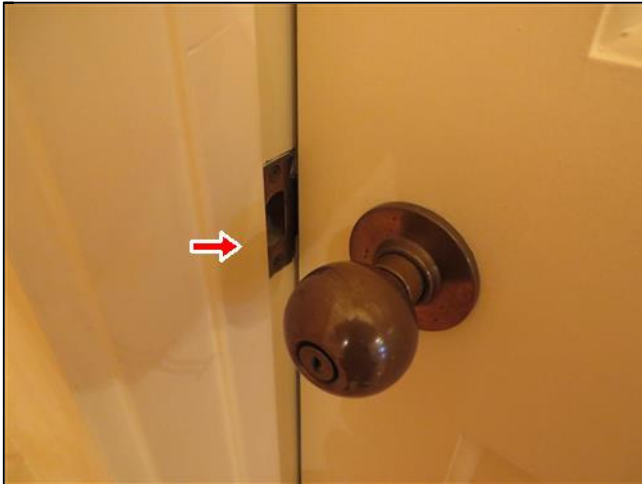
4.0.B Item 1(Picture)

**4.0.B** Guest bedroom's entrance door was not closing properly, (not latching, see photo) adjustment, lubrication and or repair is recommended. We recommend contacting a licensed locksmith or door contractor for further evaluation and all needed repair.

Guest bedroom's entrance door was not closing properly, (not latching, see photo) adjustment, lubrication and or repair is recommended. We recommend contacting a licensed locksmith or door contractor for further evaluation and all needed repair.

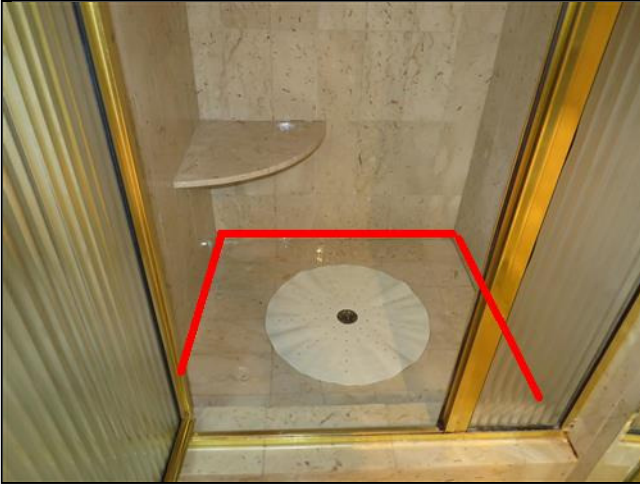
5.10.A Item 1(Picture)

**5.10.A** Grout is loose and or missing at the stall shower in the master bathroom (see photo), re-grouting and or caulking along the floor and corners of the stall shower is needed to prevent water intrusion. We recommend contacting a licensed tile contractor or a qualified handyman for further evaluation and all needed repair.

Grout is loose and or missing at the stall shower in the master bathroom (see photo), re-grouting and or caulking along the floor and corners of the stall shower is needed to prevent water intrusion. We recommend contacting a licensed tile contractor or a qualified handyman for further evaluation and all needed repair.

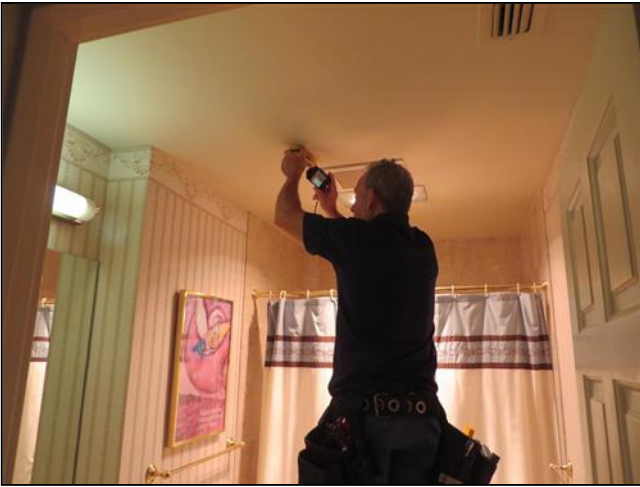
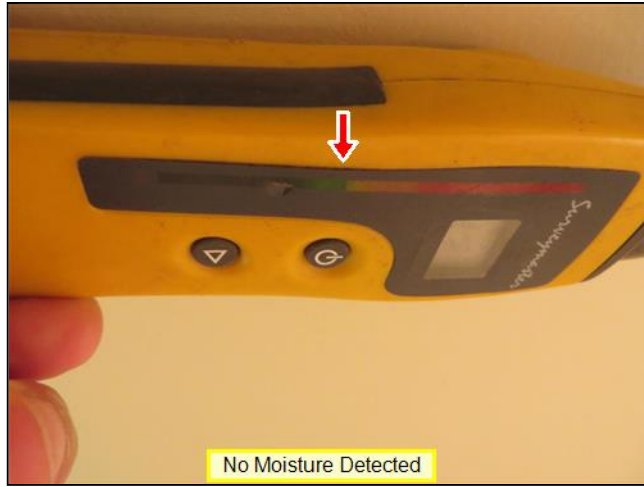
**5.2.B** Ceiling was tested for moisture, no moisture was detected at time of inspection.

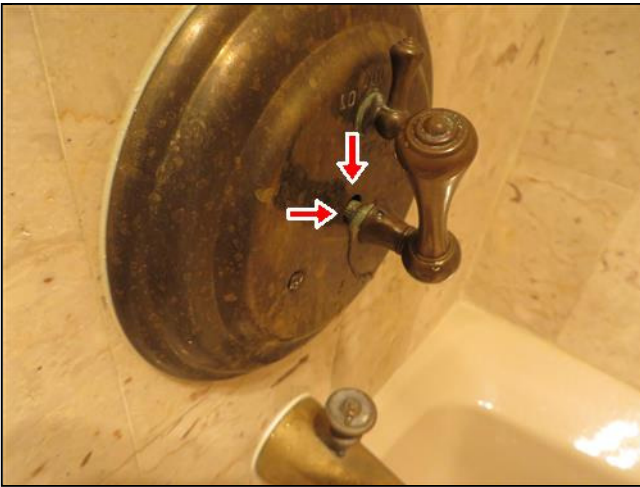
5.9.B Item 1(Picture)

**5.9.B** Tub's control handle leaks when water is turned on in the guest bathroom (see photo), repair is needed. We recommend contacting a licensed plumber for repair.

Tub's control handle leaks when water is turned on in the guest bathroom (see photo), repair is needed. We recommend contacting a licensed plumber for repair.

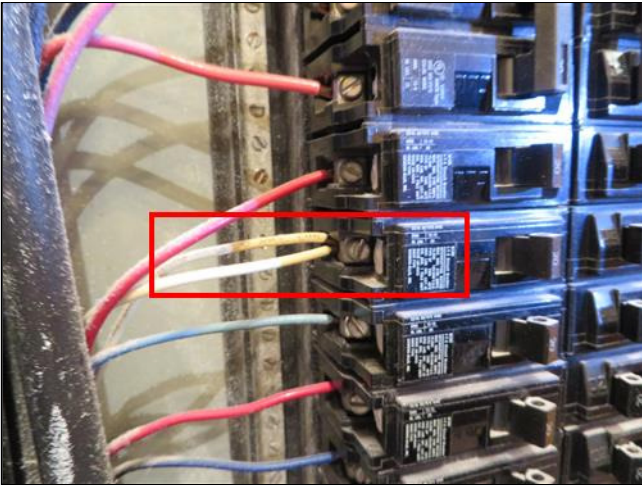
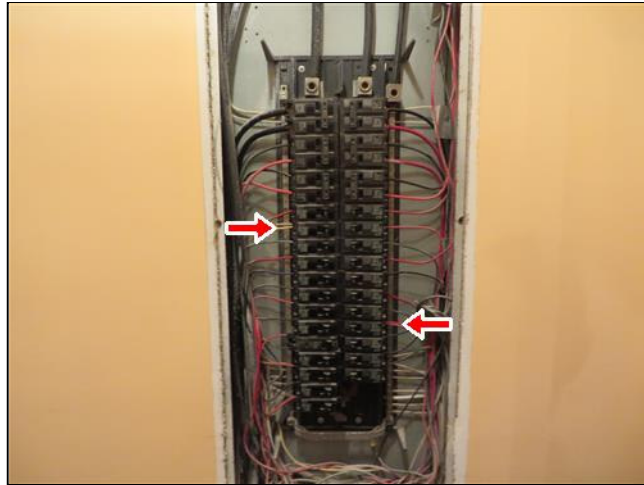
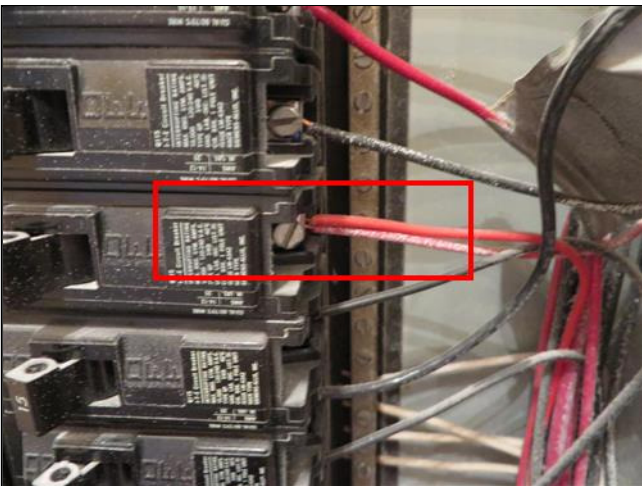
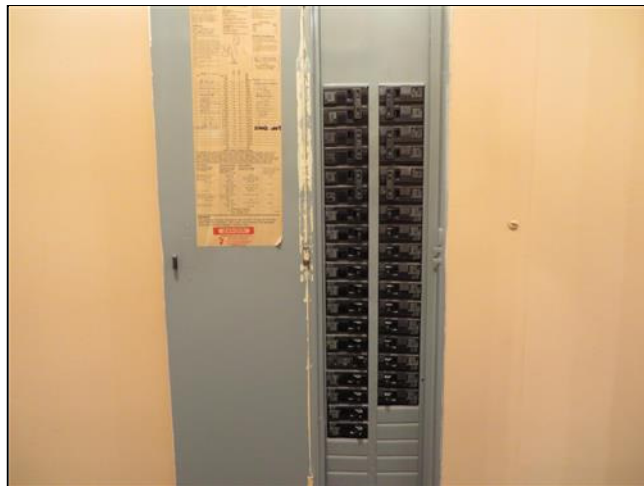
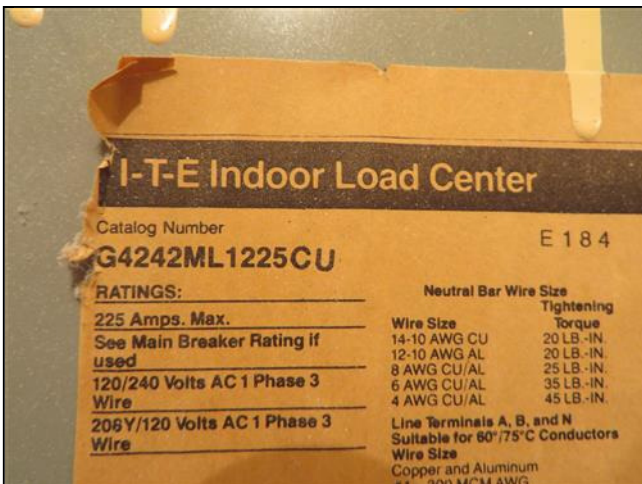
**6.2** Two circuit breakers are doubled wired, (see photos) repair is needed to prevent electrical shock or possible fire. We recommend contacting a licensed electrician for further evaluation and all needed repair.

Two circuit breakers are doubled wired, (see photos) repair is needed to prevent electrical shock or possible fire. We recommend contacting a licensed electrician for further evaluation and all needed repair.

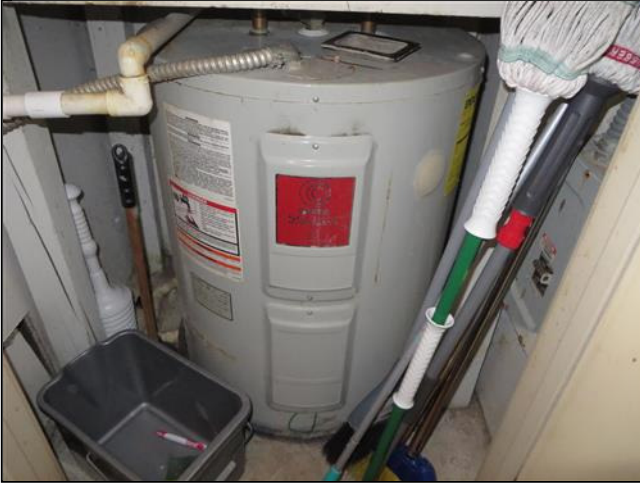
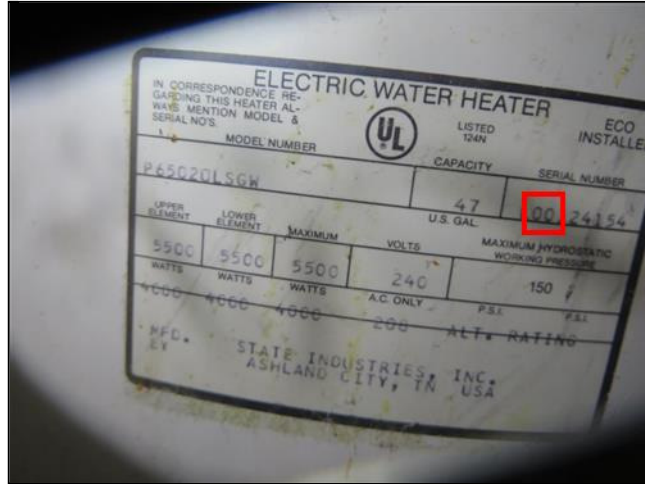
**7.0** Hot water heater was in "age noted" functional condition at time of inspection, no leaks were observed, and water temperature was set at +/- 115 degrees.

NOTE: The State of Florida requires us to inform you of the typical life cycle or life expectancy of an electric hot water heater. Manufactures suggested life expectancy for an electric water heater is 13 - 15 years. This "age noted" electric water heater (manufacture date 2000) was functioning as intended and no visible defects were observed at time of inspection. Due to the age of this water heater, installing a new energy efficient water heater in the near future would reduce your energy cost and prevent possible leak and or flooding. We recommend contacting a licensed plumber for further evaluation and replacement if needed.

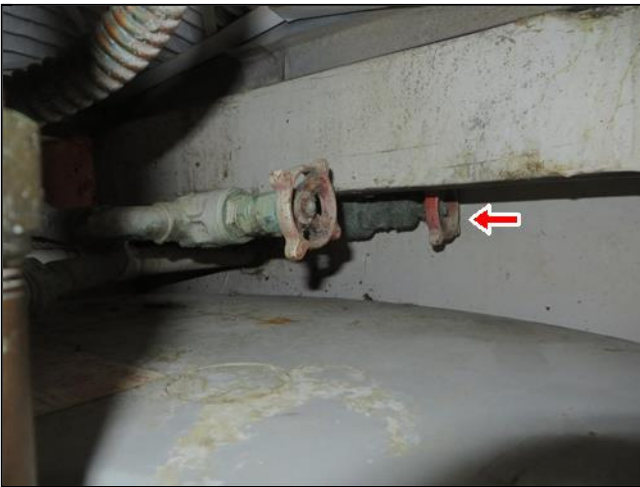
7.1 Item 1(Picture)

**7.1** The water main shut off valve is located in the utility closet above the hot water heater (see photo). No defects or leaks were observed at water main line or valve at time of inspection.

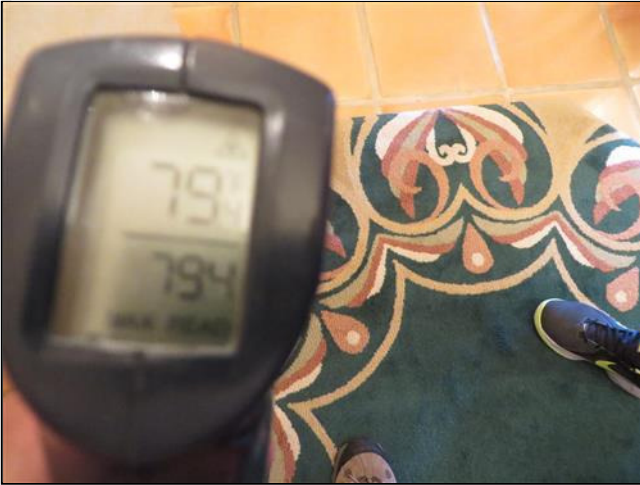
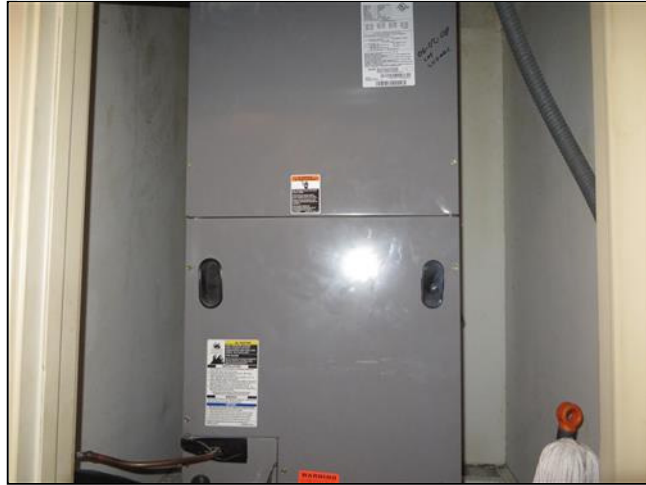
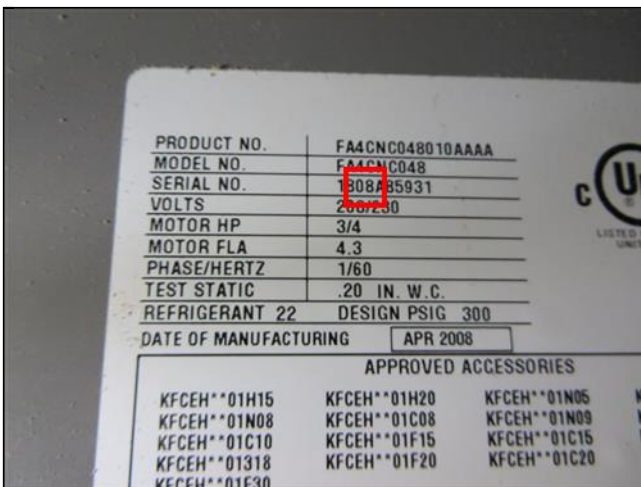
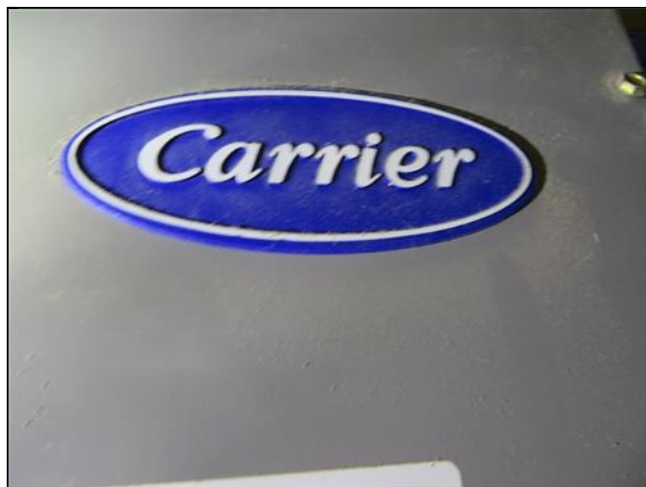
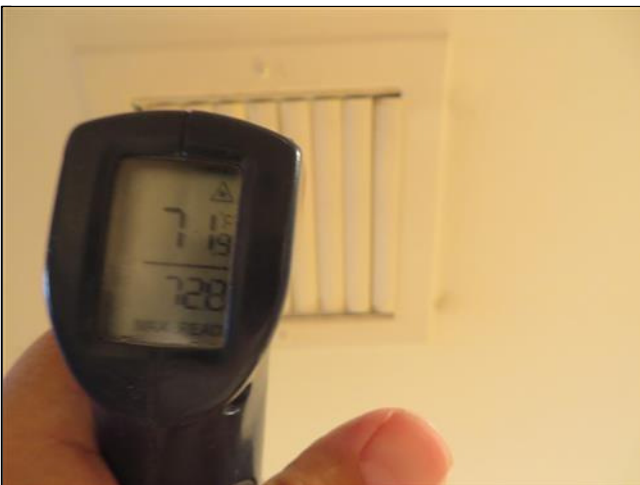
**8.0** Ambient air test was performed by using thermometers at the air handler on this Split System Air Conditioner system to determine if the difference in temperatures of the supply and return air are between 14 degrees and 22 degrees which indicates the air conditioning unit is cooling as intended. The supply air temperature on your system read 70 degrees, and the return air temperature was 79 degrees. This indicates this air conditioning system is **not cooling properly or as intended**. We recommend a licensed Heat/Air contractor should inspect this air conditioning system for further evaluation and all needed repairs.

Ambient air test was performed by using thermometers at the air handler on this Split System Air Conditioner system to determine if the difference in temperatures of the supply and return air are between 14 degrees and 22 degrees which indicates the air conditioning unit is cooling as intended. The supply air temperature on your system read 70 degrees, and the return air temperature was 79 degrees. This indicates this air conditioning system is **not cooling properly or as intended**. We recommend a licensed Heat/Air contractor should inspect this air conditioning system for further evaluation and all needed repairs.

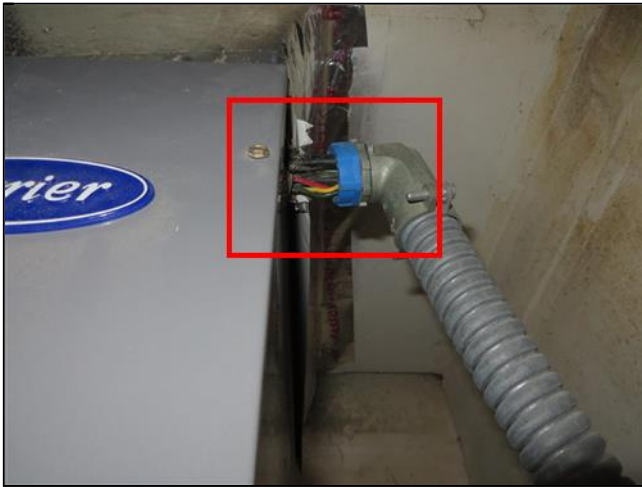
8.3 Item 1(Picture)

Electrical conduit at air handler is loose (see photo 1), repair is needed to prevent electrical shock. We recommend contacting a licensed air conditioner or electrical contractor for further evaluation and repair.

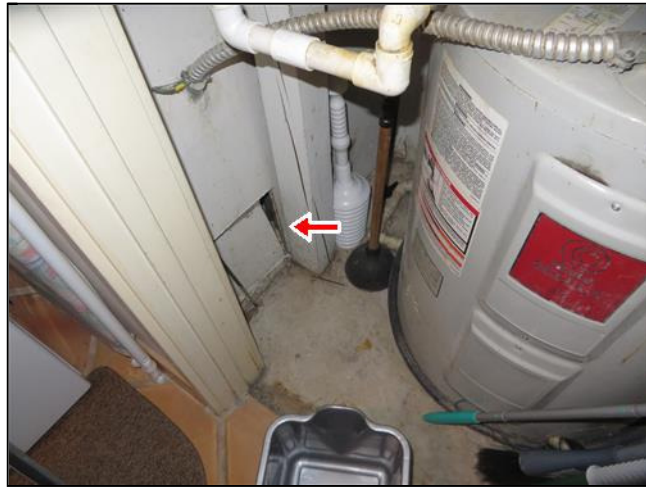
8.3 Item 2(Picture)

Cosmetic note: damaged drywall was observed on the wall in the utility closet (see photo 2), repair is recommended. Contact a drywall contractor for repair.

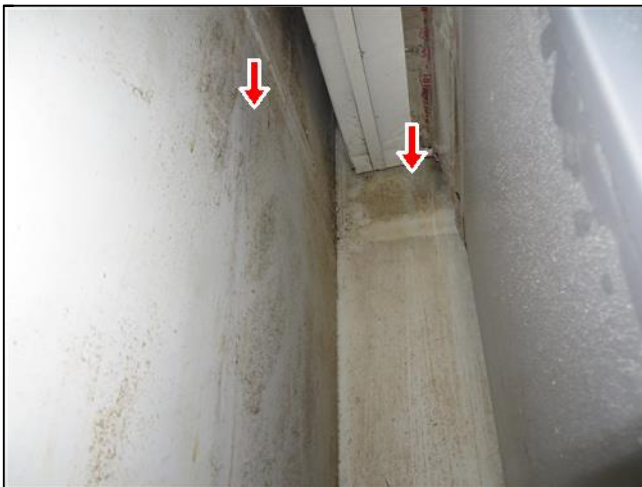
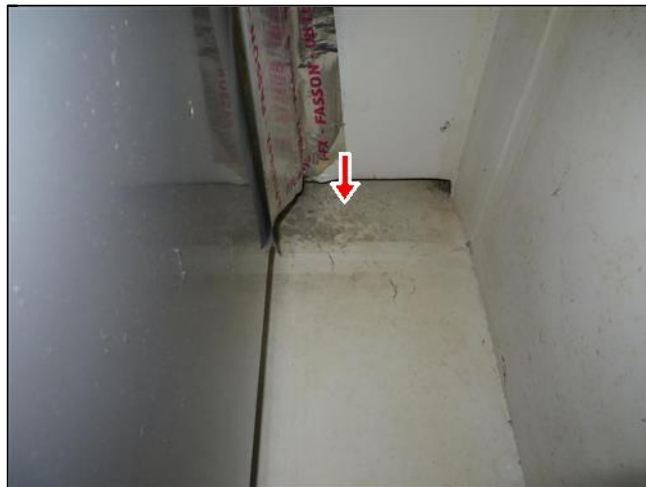
Surface mold was observed on the utility closet walls near the air handler (see photos 3 & 4), cleaning is needed. We recommend cleaning affected area with bleach and water solution (10% bleach- 90% water). Contact a qualified handyman for repair. **FYI: when working with bleach, always be sure to protect your eyes.**

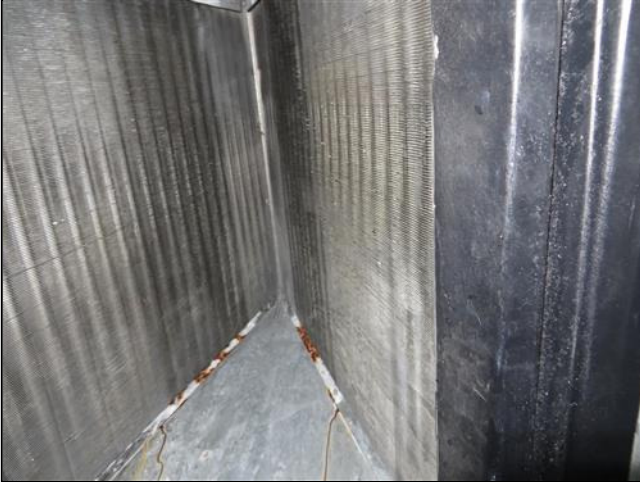
8.4 Item 1(Picture)

**8.4** Evaporator coils at the air conditioner's air handler were clean and in functional condition. No defects were observed at time of inspection.

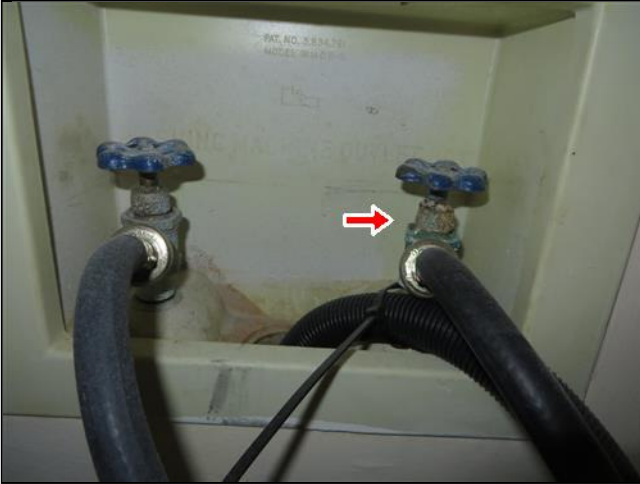
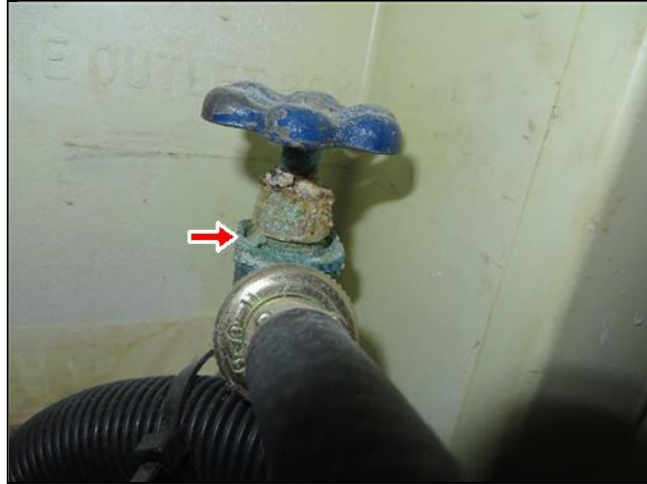
**10.4** Washing machine's supply line shut off valve has area with corrosion (see photos), repair or replacement is recommended. We recommend contacting a licensed appliance service contractor for further evaluation and all needed repair.
