Allstate Home Inspections, Inc.

Property
1234 Washingtonia Avenue
Townhouses By The Sea
Lauderdale by the Sea, Florida 33308

Report ID:
151115-2WF

Inspection Date:
11/15/2015

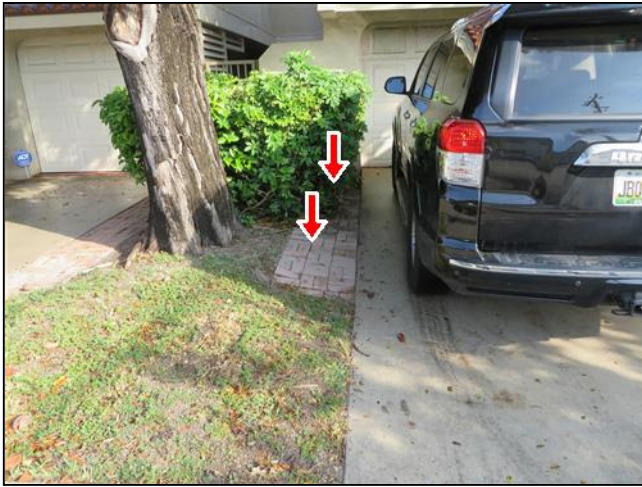
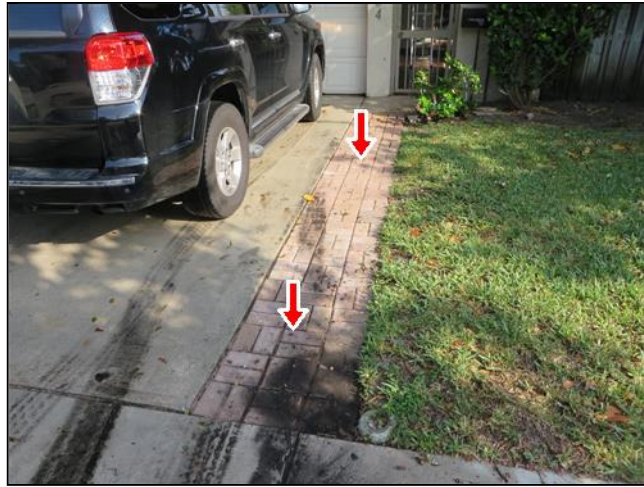
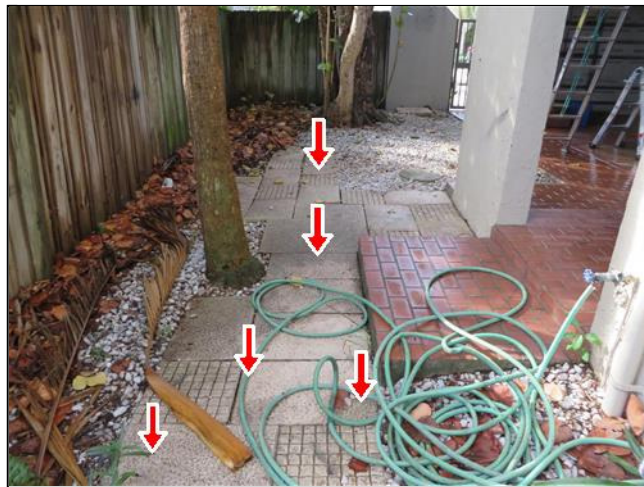
1.1 Pavers have uneven surfaces that may cause trip hazard (see photos), repair is recommend to prevent injury. Contact a licensed paver contractor or qualified handyman for all needed repairs.

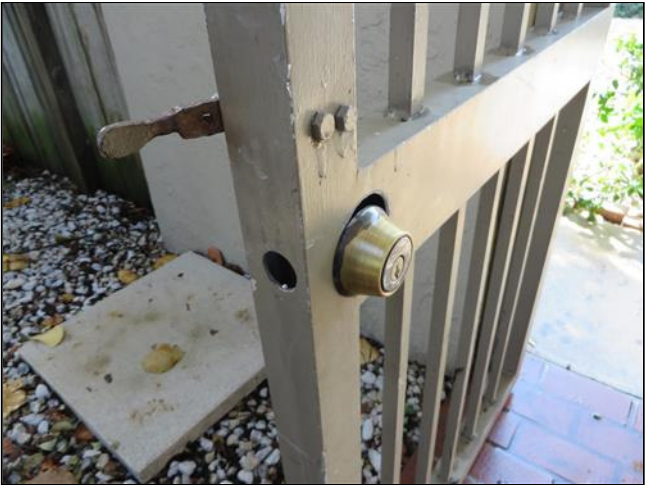
1.3 Item 1(Picture)

1.3 Gate is missing door knob (see photo), repair is recommended. We recommend contacting a qualified handyman for repair.

Gate's deadbolt lock is loose and non functional (see photo), adjustment and or repair is needed. We recommend contacting a qualified handyman for all needed repair.

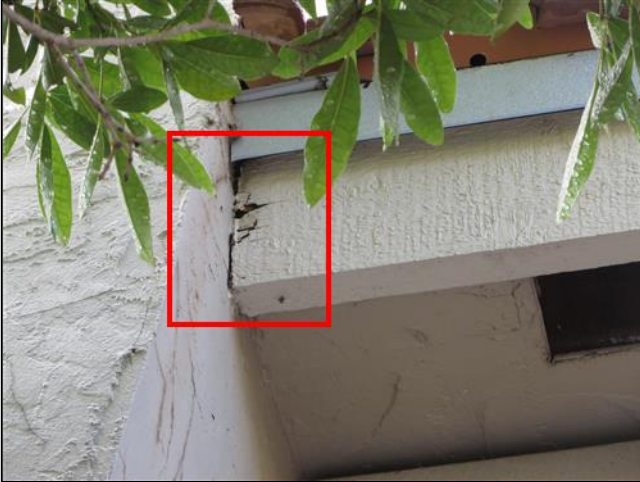
2.0 Item 1(Picture)

2.0 Fascia board has area with wood rot damage that needs repair (back of house near chimney, see photos). We recommend contacting a professional carpenter for further evaluation and all needed repair.

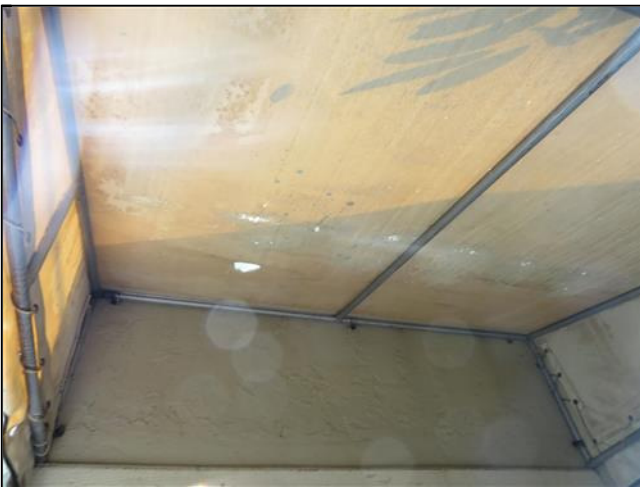
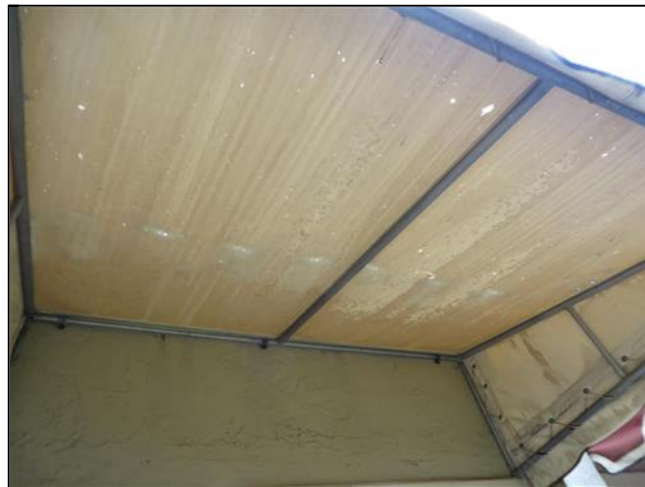
3.0 The patio canvas awnings are damaged (holes in canvas, see photos), repair is recommended. We recommend contacting a canvas service contractor for repairs.

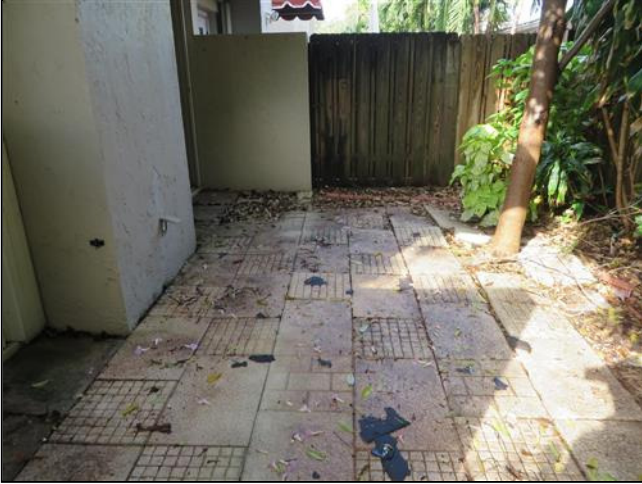
3.1 Item 1(Picture)

3.1 Patio pavers have uneven surfaces, repair is recommended to prevent trip hazard. We recommend contacting a licensed paver contractor for further evaluation and all needed repairs.

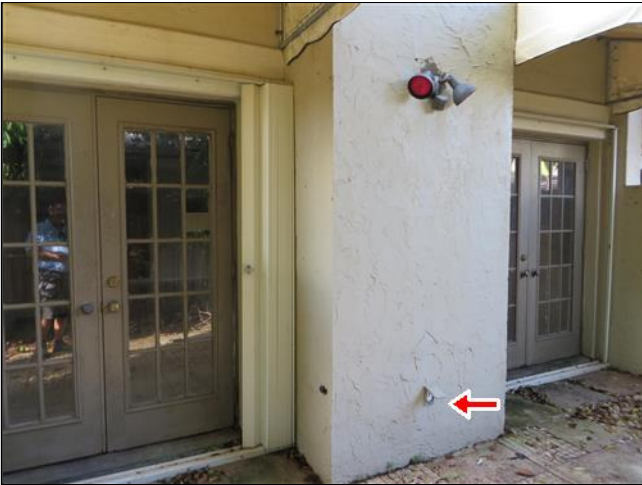
3.2 Item 1(Picture)

3.2 Electrical outlet in the patio is non functional, repair is recommend to prevent electrical shock. We recommend contacting a licensed electrician for further evaluation and repair.

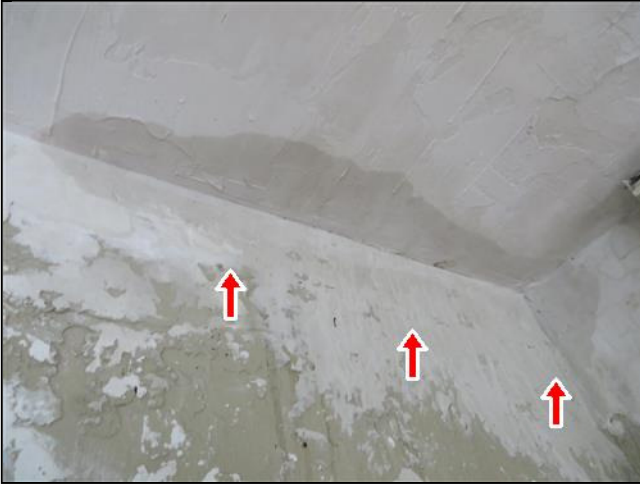
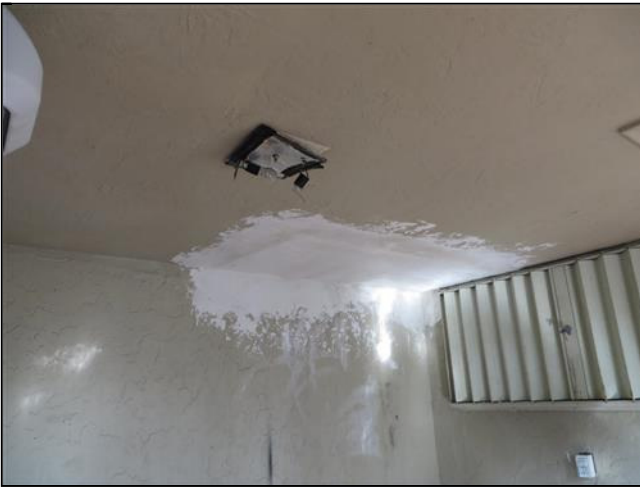
5.0 Previous repairs and water stain was observed on the carport ceiling and wall (see photos), areas were tested for moisture with moisture monitor, **moisture was detected** at time of inspection. These stains are caused by an active roof leak. We recommend contacting a licensed roofing contractor for further evaluation and all needed repair.

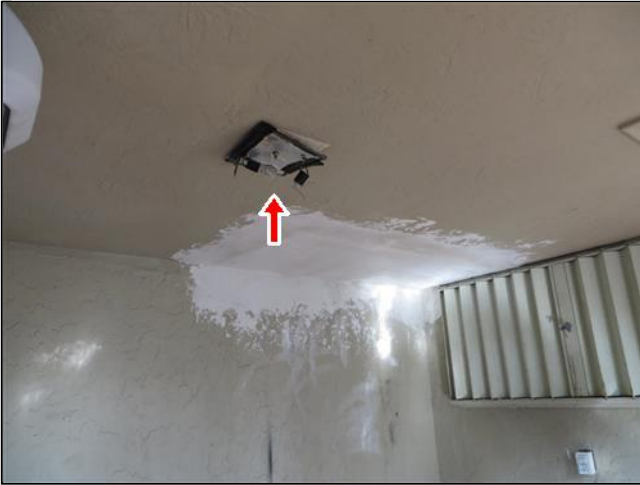
5.3 Item 1(Picture)

5.3 Light fixture on carport ceiling is damaged and non functional (see photo), repair is recommended. Contact a licensed electrician for further evaluation and all needed repair.

Electrical outlet in the carport is non functional, repair is recommend to prevent electrical shock. We recommend contacting a licensed electrician for further evaluation and repair.

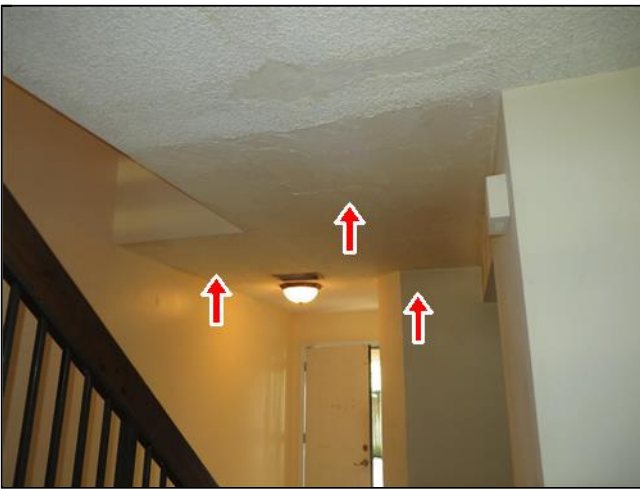
7.2.A Item 1(Picture)

7.2.A Previous repair was observed on the entrance foyer ceiling (see photos), area was tested for moisture with moisture monitor, **NO MOISTURE WAS DETECTED** at time of inspection. Staining appears to be from an old air conditioning drain line leak which seems to have been corrected. **We recommend that the buyer continue to monitor the stained area or areas and contact a licensed air conditioning contractor** if the stain appears to change color and/or a visible leak is observed.

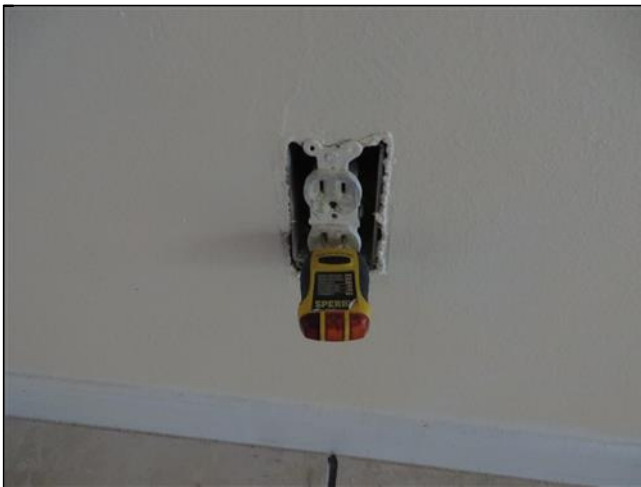
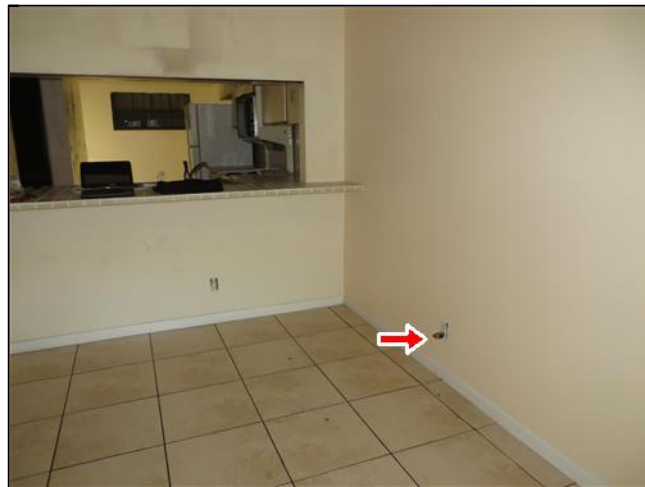
7.3.C The electrical outlet receptacle in the dining room has object stuck in receptacle for ground (see photos 1 & 2), repair is recommend to prevent electrical shock. We recommend contacting a licensed electrician for further evaluation and all needed repair.

Electrical outlet cover plates on the walls of the dining room were missing, we recommend replacing with new cover plates to prevent electrical shock. Contact a qualified handyman for repair.

Exposed wires were observed on the ceiling in the dining room where light fixture is missing, repair is needed to prevent electrical shock. We recommend contacting a licensed electrician for further evaluation and all needed repairs.

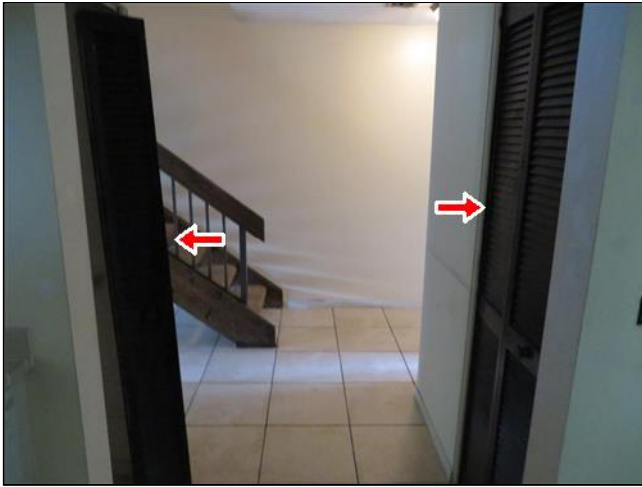
7.0.D Item 1(Picture)

7.0.D Kitchen bifold closet doors are damaged and are not opening and or closing properly, repair and or adjustment is needed. We recommend contacting a licensed door contractor or a qualified handyman for further evaluation and all needed repair.

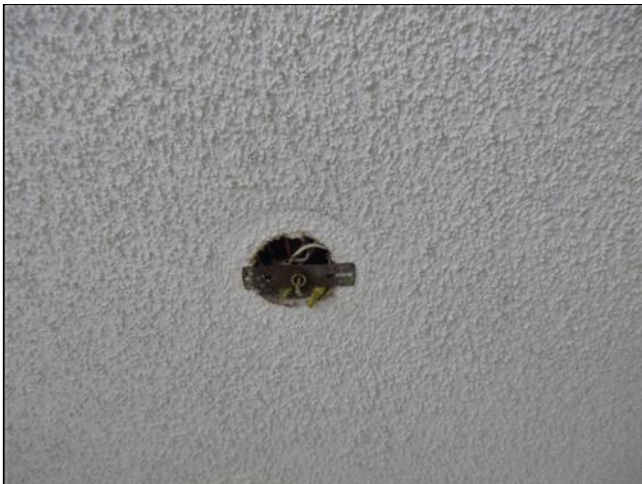
7.3.D Item 1(Picture)

7.3.D Both light fixtures on the kitchen ceiling were missing, replacement is recommended. We recommend contacting a licensed electrician for further evaluation and all needed repair.

Electrical outlet cover plates on the wall of the kitchen are missing, we recommend replacing with new cover plates to prevent electrical shock. Contact a qualified handyman for repair.

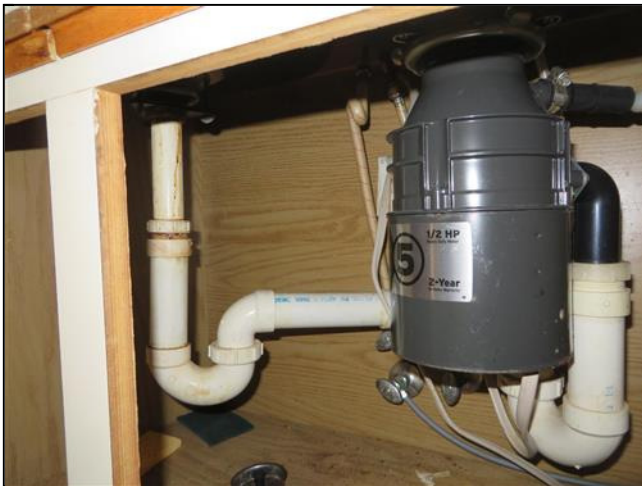
8.4 Item 1(Picture)

8.4 Garbage disposer was non functional and leaks when water is running at the kitchen sink, repair or replacement is recommended. We recommended contacting a licensed plumber or qualified handyman for further evaluation and replacement.

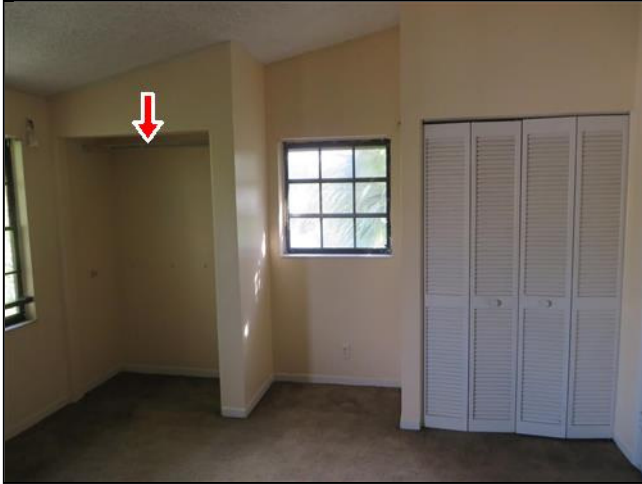
9.0.A Item 1(Picture)

9.0.A Master bedroom's closet doors are missing (see photo), replacement is recommended. We recommend contacting a licensed door contractor or a qualified handyman for further evaluation and all needed repair.

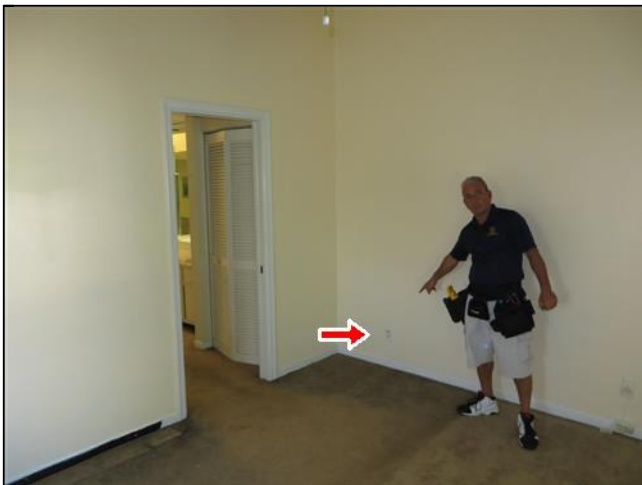
9.3.A Item 1(Picture)

9.3.A The electrical outlet receptacle in the master bedroom is damaged (see photo 1), repair is recommend to prevent electrical shock. Contact a licensed electrician or a qualified handyman for repair.

Electrical outlet cover plates in master bedroom are missing, we recommend replacing with new cover plates to prevent electrical shock. Contact a qualified handyman for repair.

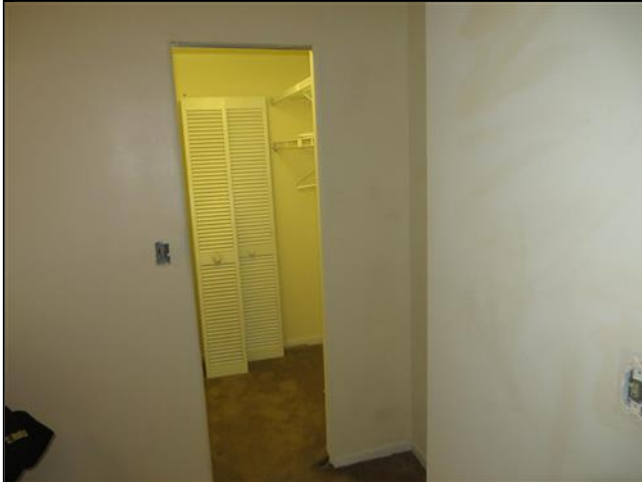
9.0.B Item 1(Picture)

9.0.B Guest bedroom closet doors are not installed (doors are inside the close, see photo), repair is recommended. We recommend contacting a carpenter or a qualified handyman for all needed repair.

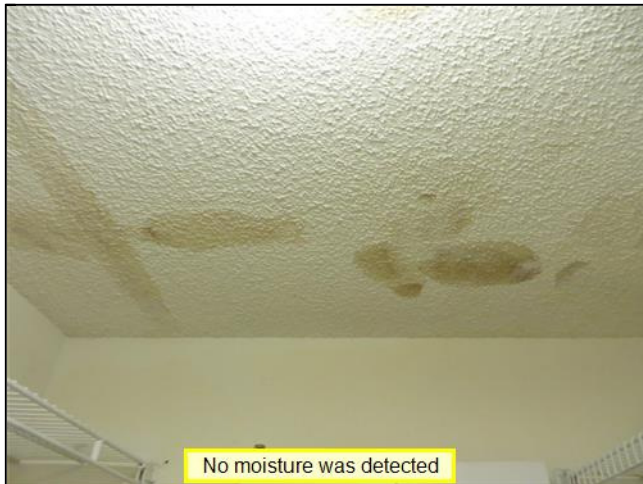
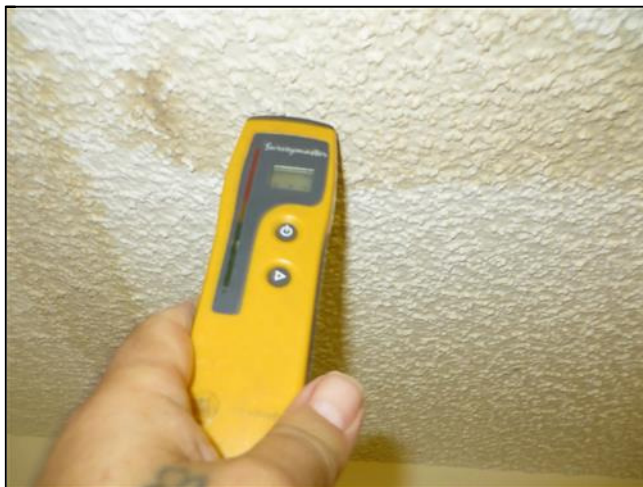
9.2.B Water stains were observed on the guest bedroom ceiling (see photos), areas were tested for moisture with moisture monitor, **NO MOISTURE WAS DETECTED** at time of inspection. Staining appears to be from an old roof leak which seems to have been corrected. **We recommend that the buyer continue to monitor the stained area or areas and contact a licensed roofing contractor** if the stain appears to change color and/or a visible leak is observed.

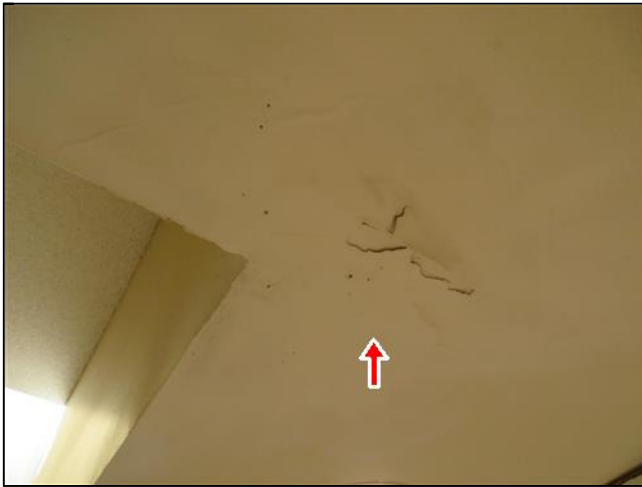
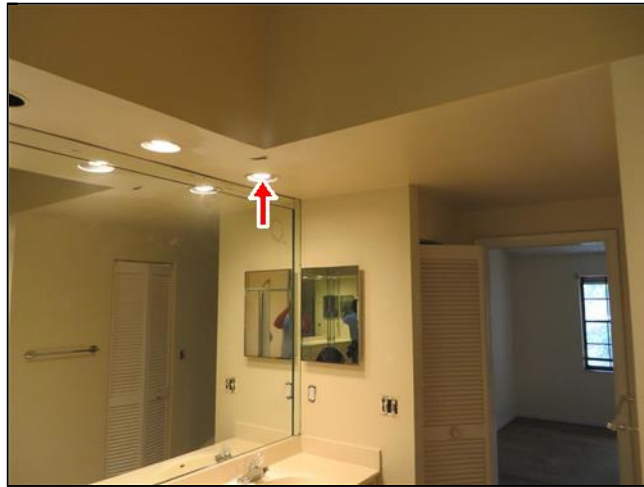
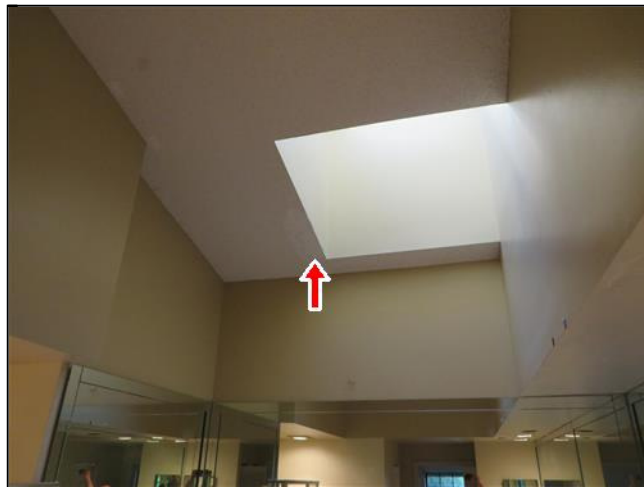
10.2.A Water stains were observed on the master bathroom ceiling (see photos), areas were tested for moisture with moisture monitor, **NO MOISTURE WAS DETECTED** at time of inspection. Staining appears to be from an old roof leak which seems to have been corrected. **We recommend that the buyer continue to monitor the stained area or areas and contact a licensed roofing contractor** if the stain appears to change color and/or a visible leak is observed.

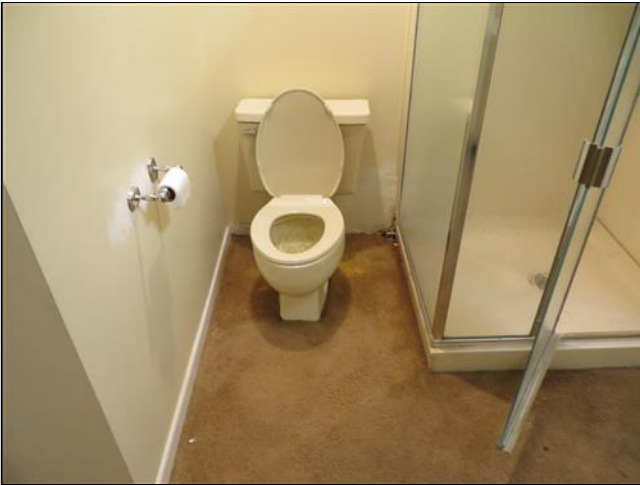
10.7.A Item 1(Picture)

10.7.A Master bathroom's toilet is loose and needs to be resealed. (replace wax seal and tighten bolts). We recommend contacting a licensed plumber for further evaluation and all needed repair.

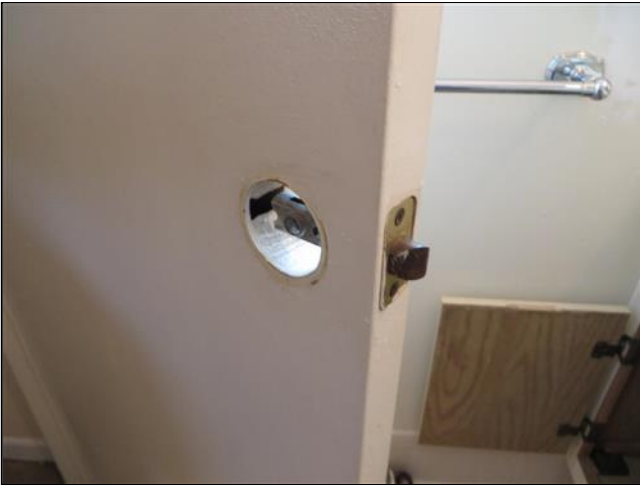
10.0.B Item 1(Picture)

10.0.B Guest bathroom's entrance door knob is missing (see photo), repair is needed. We recommend contacting a licensed locksmith or a qualified handyman for repair.

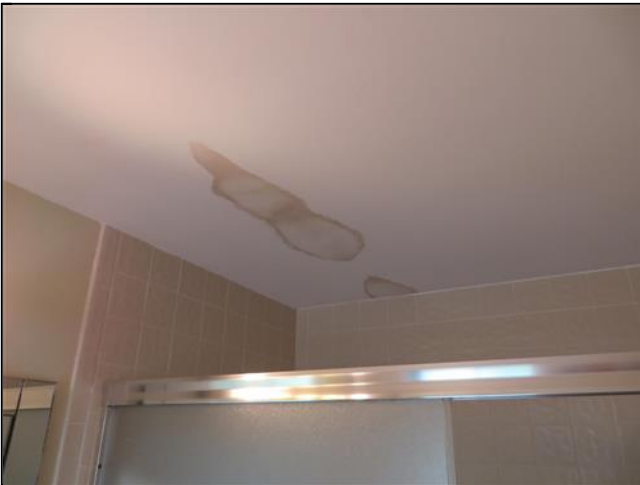
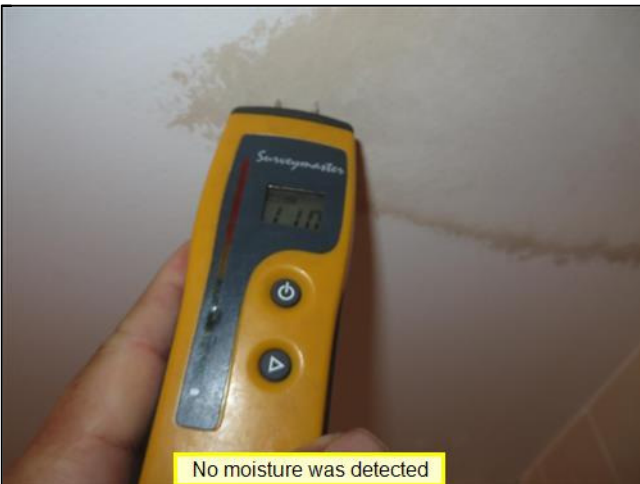
10.2.B Water stains were observed on the guest bathroom ceiling (see photos), areas were tested for moisture with moisture monitor, **NO MOISTURE WAS DETECTED** at time of inspection. Staining appears to be from an old roof leak which seems to have been corrected. **We recommend that the buyer continue to monitor the stained area or areas and contact a licensed roofing contractor** if the stain appears to change color and/or a visible leak is observed.

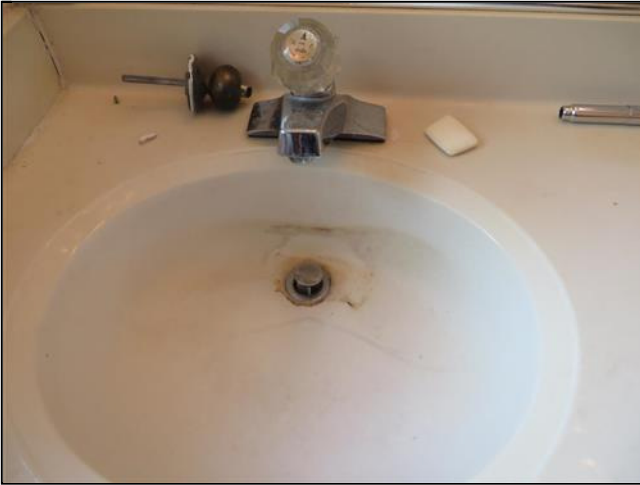
10.4.B Item 1(Picture)

10.4.B Guest bathroom's sink faucet has a drip leak (see photo), repair is recommended. We recommend contacting a licensed plumber for further evaluation and all needed repair.

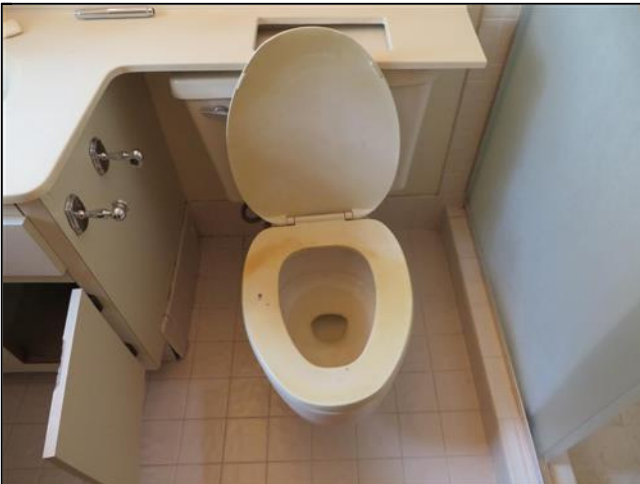
10.7.B Item 1(Picture)

10.7.B Guest bathroom's toilet is loose and needs to be reseated. (replace wax seal and tighten bolts). We recommend contacting a licensed plumber for further evaluation and all needed repair.

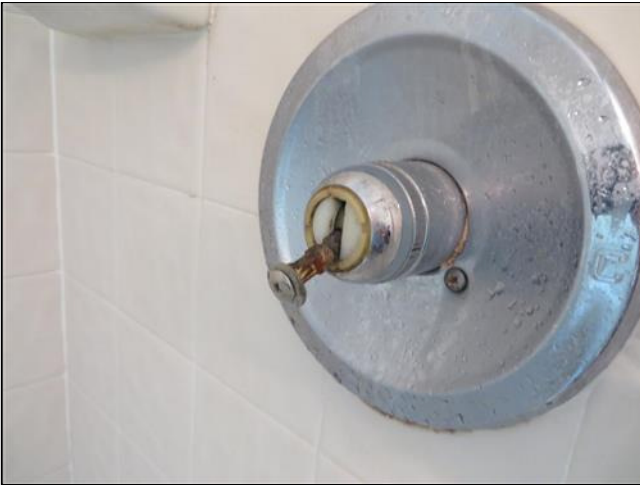
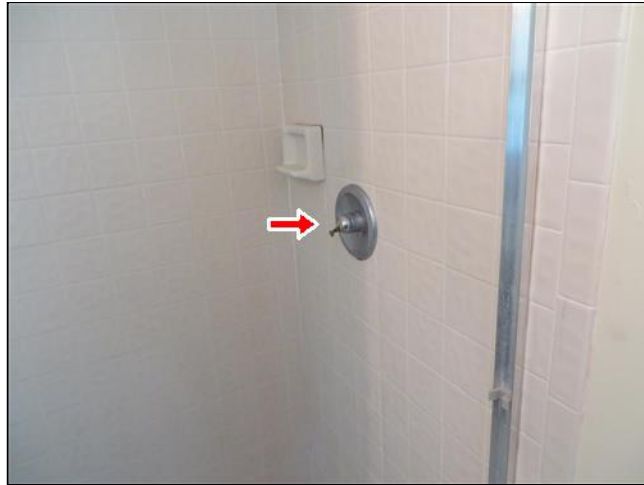
10.9.B Shower's control handle is damaged and missing in the guest bathroom (see photos), repair or replacement is recommended. We recommend contacting a licensed plumber for all needed repair.

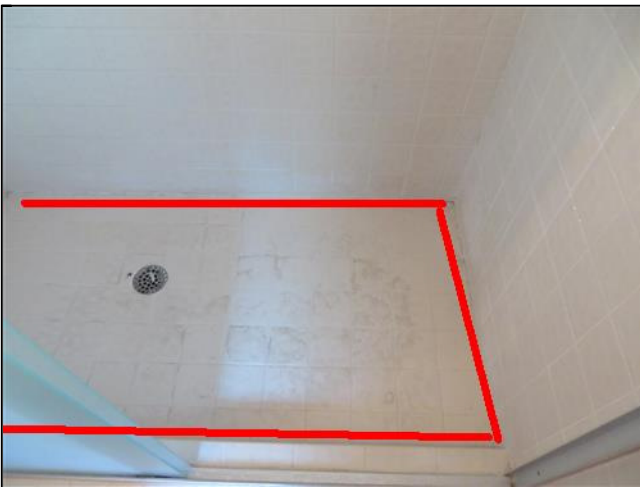
10.10.B Item 1(Picture)

10.10.B Caulking is missing at the stall shower in the guest bathroom, re-grouting and or caulking along the floor and corners of the stall shower is needed to prevent water intrusion. We recommend contacting a qualified handyman for further evaluation and all needed repair.

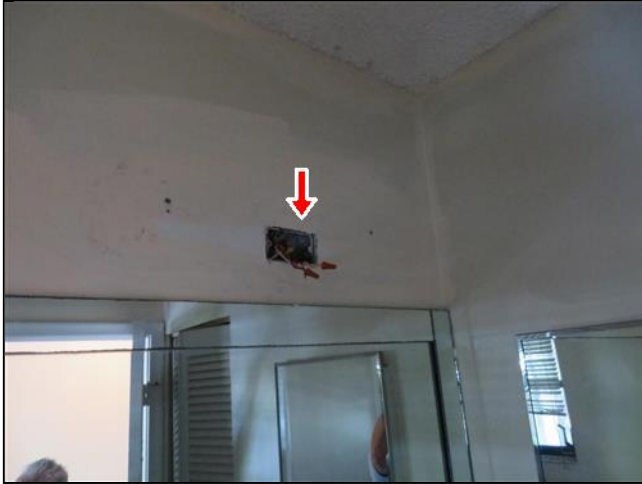
10.3.C Item 1(Picture)

10.3.C Light fixture on the wall in the half bathroom is missing (see photos 1 & 2), replacement is needed. We recommend contacting a licensed electrician for further evaluation and all needed repair.

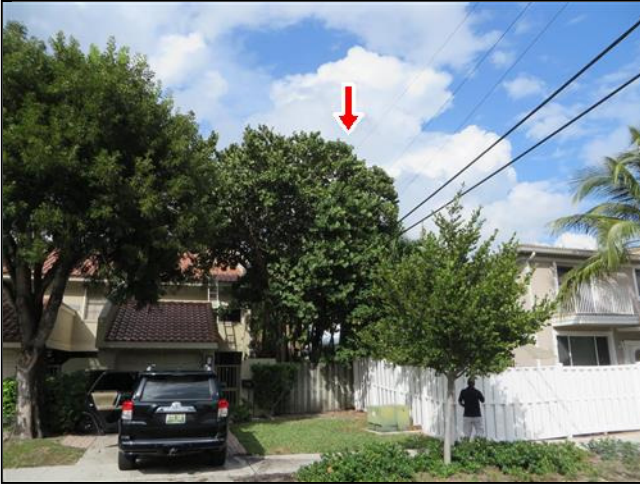
11.0 Item 1(Picture)

11.0 FP&L's power lines rub against tree branches on east side of property (see photo), we recommend trimming back all branches and vegetation to prevent electrical shock. **Contact FPL or licensed electrical contractor for removal of branches.**

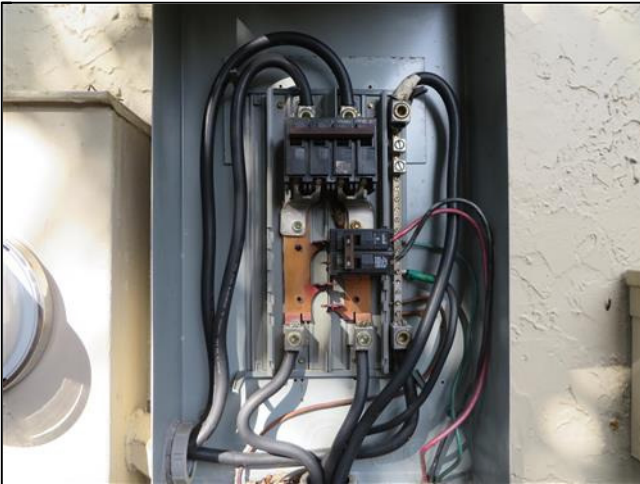
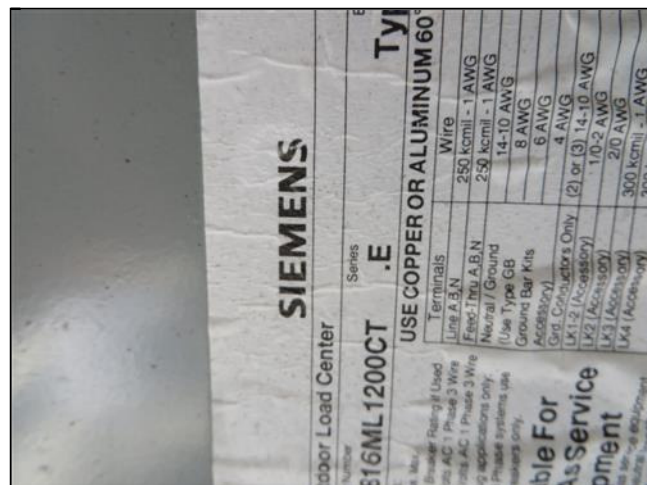
11.2 Exterior electrical main service disconnect panel box, conductors and breakers appeared to be in functional condition, no defects were observed at time of inspection.

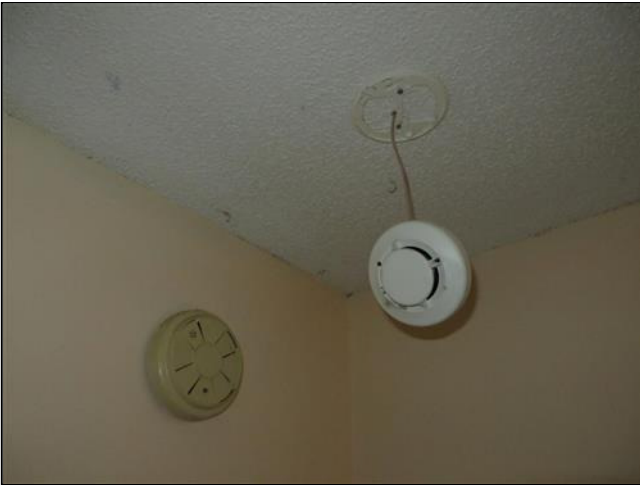
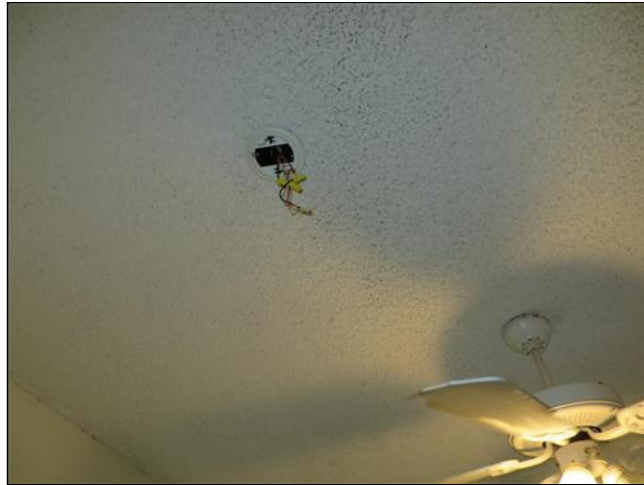
11.6 Smoke detectors were damaged and or missing, replacement is recommend. We recommend installing new smoke and or fire detectors to ensure your safety.

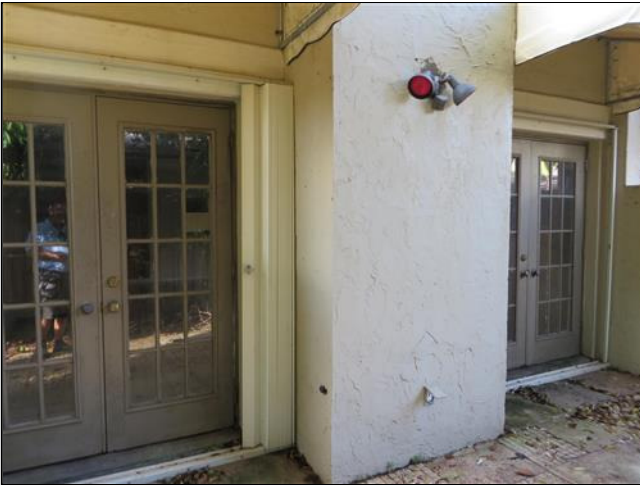
11.7 Item 1(Picture)

11.7 Exterior flood lights were non functional (see photo), repair or replacement is recommended. We recommend contacting a licensed electrician for further evaluation and all needed repairs.

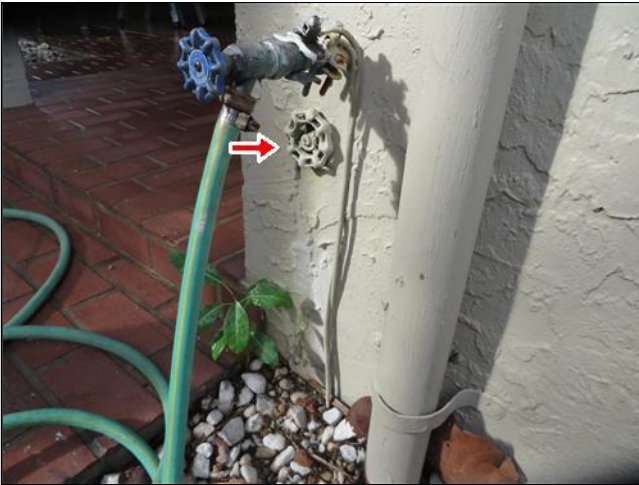
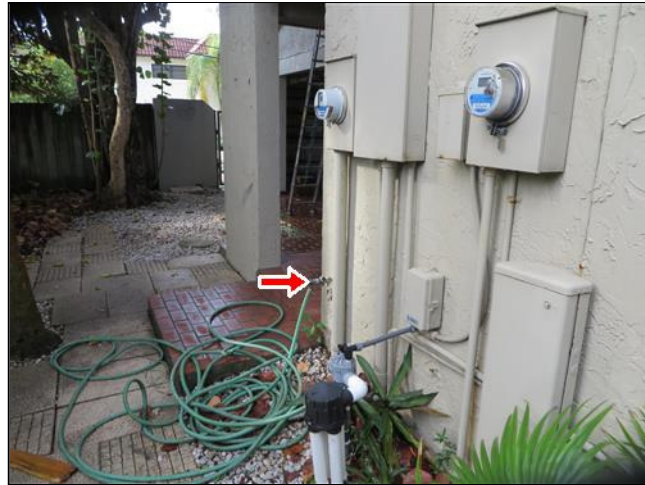
12.1 The water main shut off valve is located on the exterior wall (right side of house, see photo). No defects or leaks were observed at water main line or valve at time of inspection.

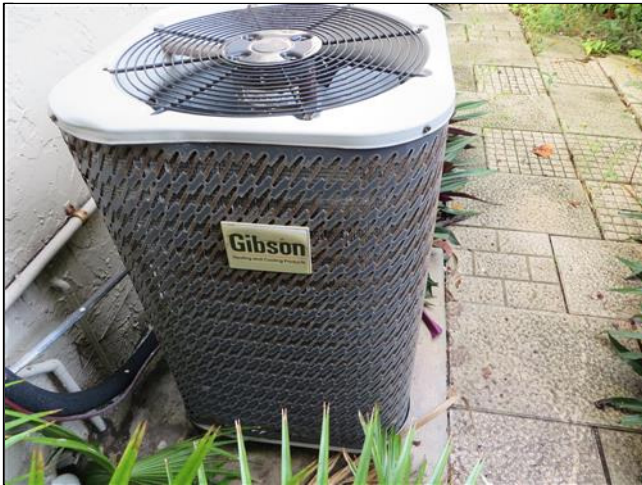
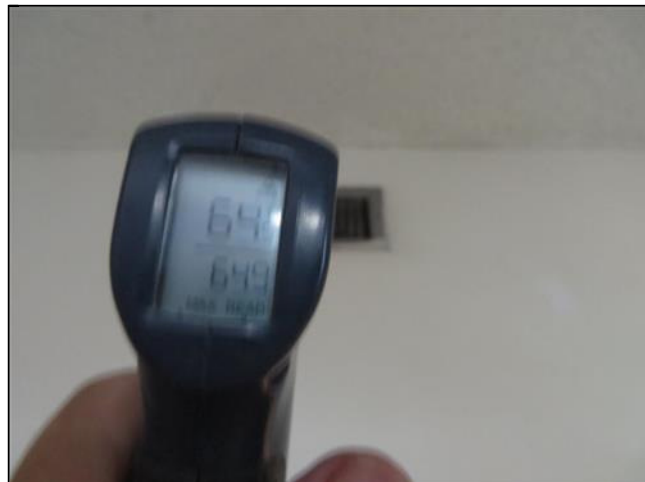
13.0 Ambient air test was performed by using thermometers at the air handler on this Split System Air Conditioner system to determine if the difference in temperatures of the supply and return air are between 14 degrees and 22 degrees which indicates the air conditioning unit is cooling as intended. The supply air temperature on your system read + / - 64 degrees, and the return air temperature was + / - 79 degrees. This indicates the range in temperature drop is normal for this air conditioning system.

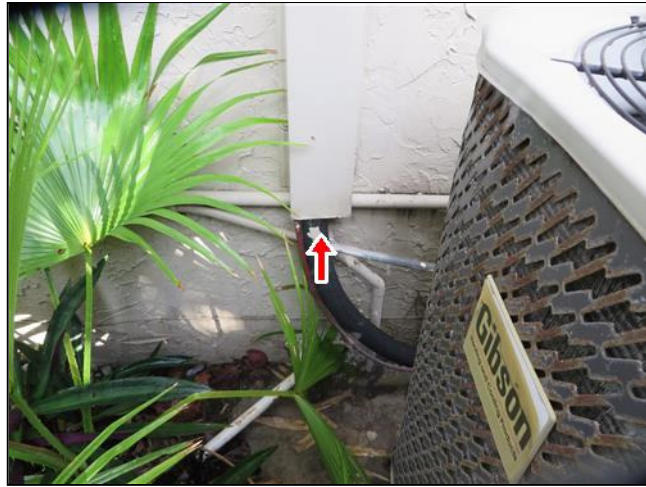
13.2 Item 2(Picture)

Screening is missing at the entrance/bottom of the chase line cover (see photo 2), repair is needed to prevent insects, rodents and lizards from entering into attic area. We recommend contacting a qualified handyman for repair.

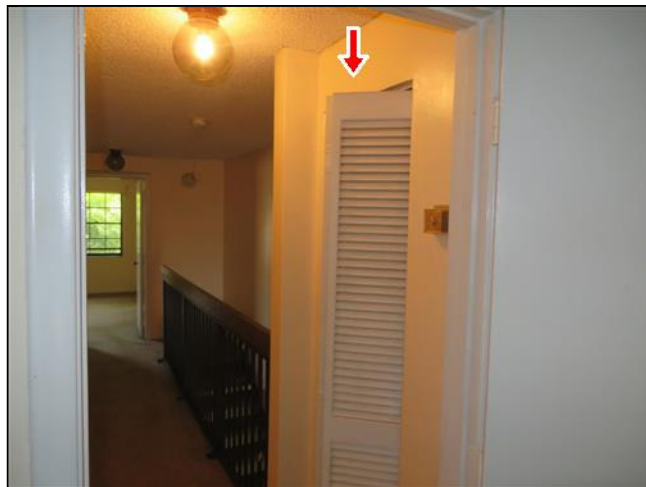
13.3 Item 2(Picture)

Door at air handler closet is not opening and closing properly (see photo 2), repair/adjustment is recommended. Contact a qualified handyman for repair.

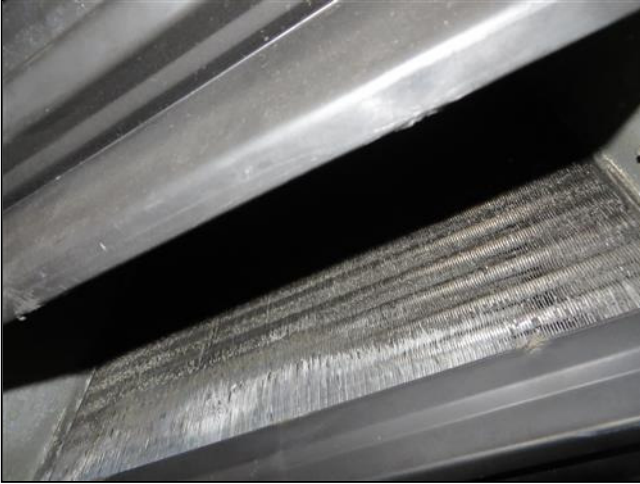
13.4 Item 1(Picture)

13.4 Evaporator coils at the air conditioners air handler were clean and in functional condition. No defects were observed at time of inspection.

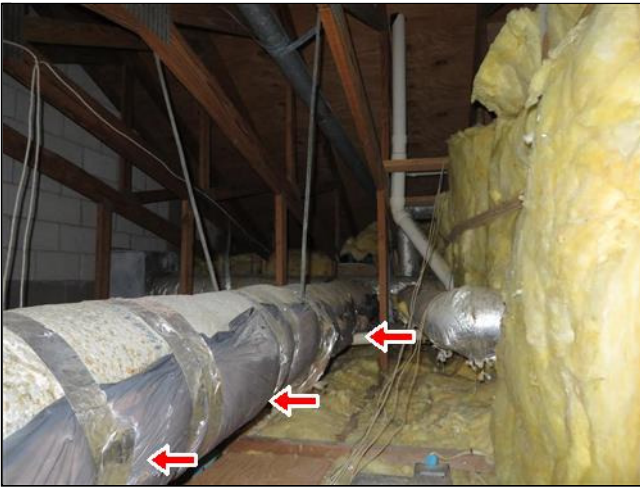
13.8 Item 1(Picture)

13.8 Air conditioner ducts in the attic are damaged (see photos), replacement is needed. We recommend contacting a licensed air conditioning service contractor for further evaluation and all needed repairs.

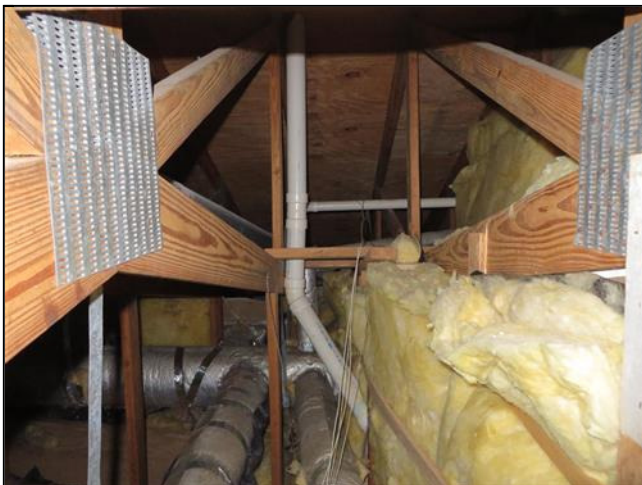
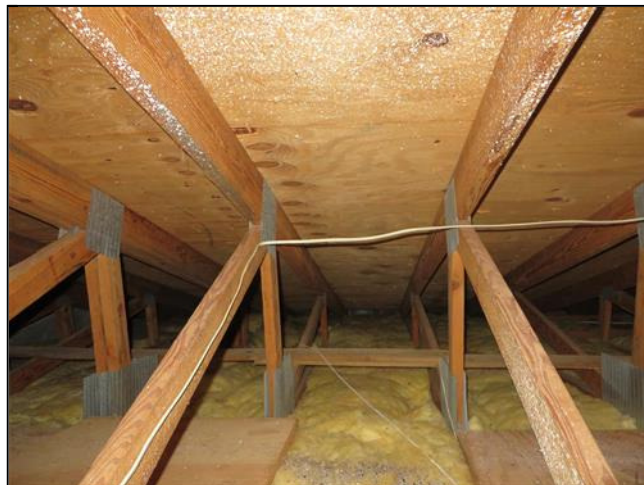
15.0 Percentage of attic inspected was approximately 65 % due to limited access from pitch of roof, air conditioning ducts, insulation, truss design, etc.

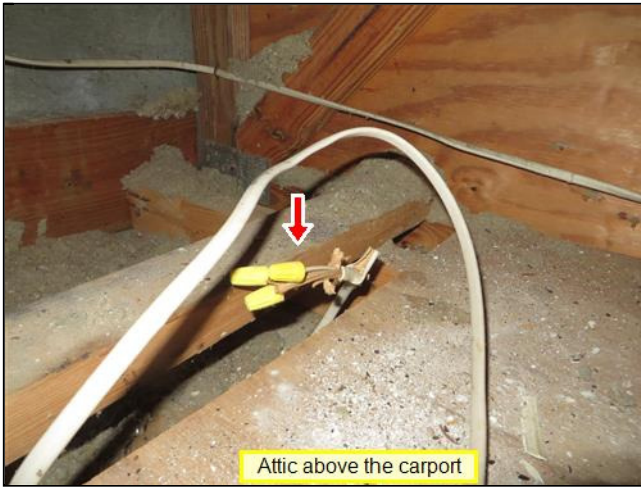
15.5 Item 1(Picture)

15.5 Open junction box and or exposed wires were observed in attic (see photo), we recommend contacting a licensed electrician for further evaluation and all needed repairs.

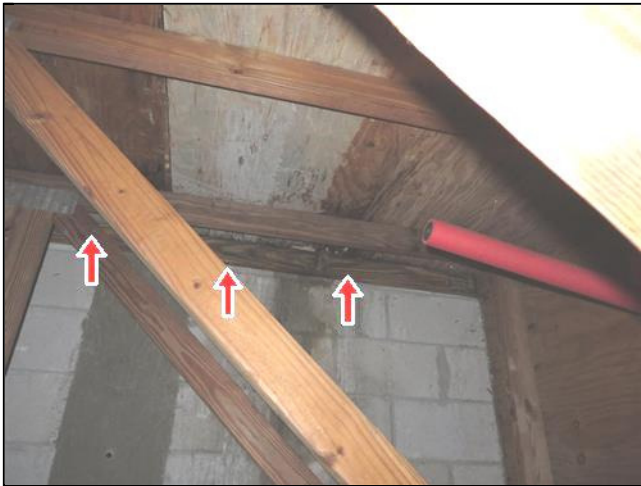
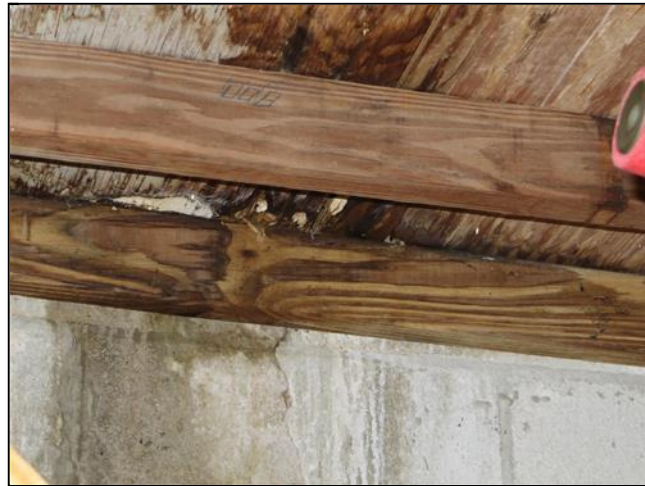
15.6 Damaged roof sheathing was observed in the attic (above the carport, see photos 1 & 2), replacement of damaged roof sheathing is needed. We recommend contacting a licensed roofing contractor for further evaluation and all needed repair.

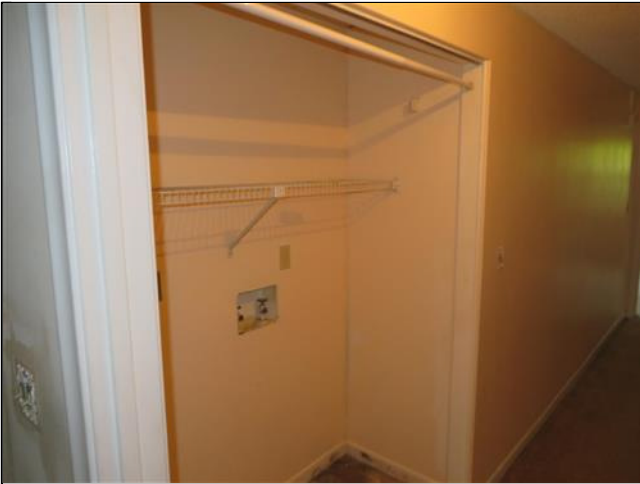
16.0 Item 1(Picture)

16.0 Laundry closet doors were missing, replacement is recommended. We recommend contacting a licensed door contractor or a qualified handyman for further evaluation and all needed repair.

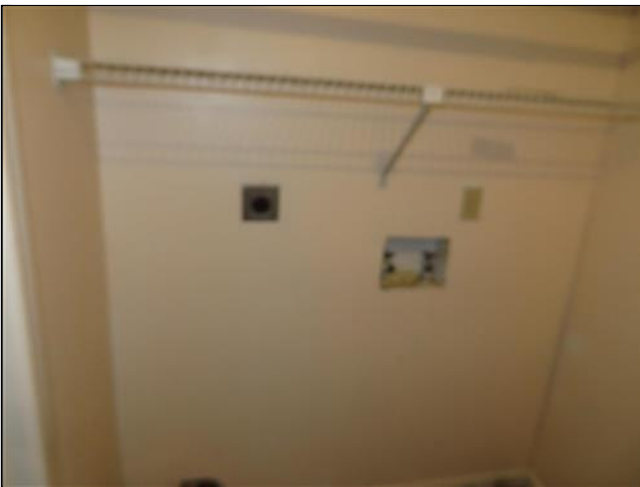
16.4 Item 1(Picture)

16.4 Washing machine and clothes dryer were not present at time of inspection. Inspector was unable to test electrical outlets, supply lines, drain and dryer vent. We recommend contacting an appliance service contractor for further evaluation and repair if needed.

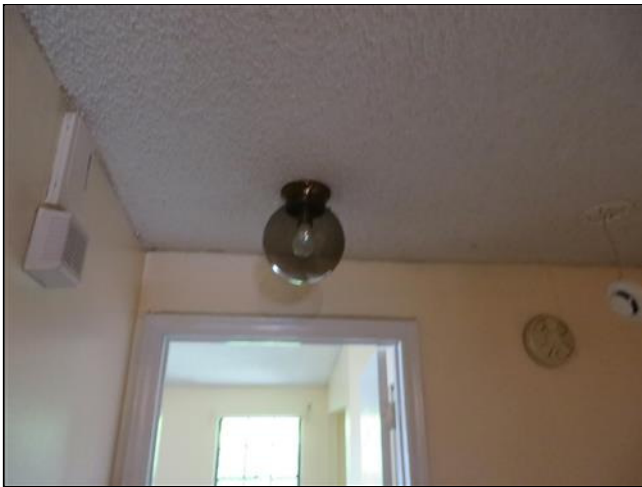
17.4 Item 1(Picture)

17.4 Light on the upstairs landing ceiling was not working at time of inspection (see photo), we recommend changing the light bulb first. If the light is still not working, contact a licensed electrician for further evaluation and all needed repair.

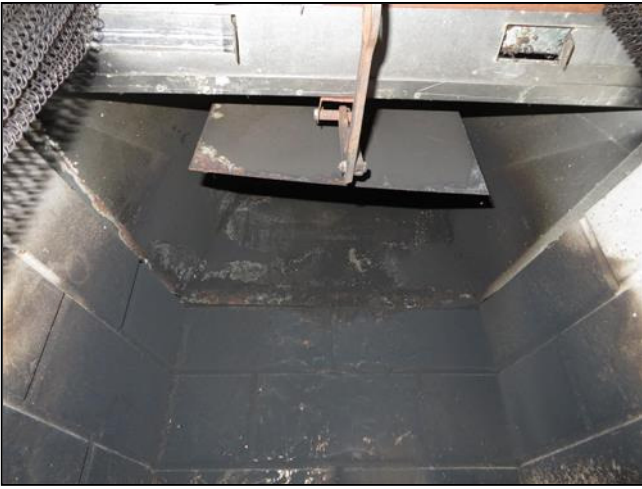
18.2 Item 1(Picture)

18.2 The damper in this fireplace is operational, functioning as intended.
