Property Inspection Report

Prepared for : Casoy Seagle

Prepared by : CHARLES CERTIFIED HOME INSPECTIONS
8950 N E 3RD AVE
ELPORTAL FL, 33138
786-389-0950
NACHI #10041001

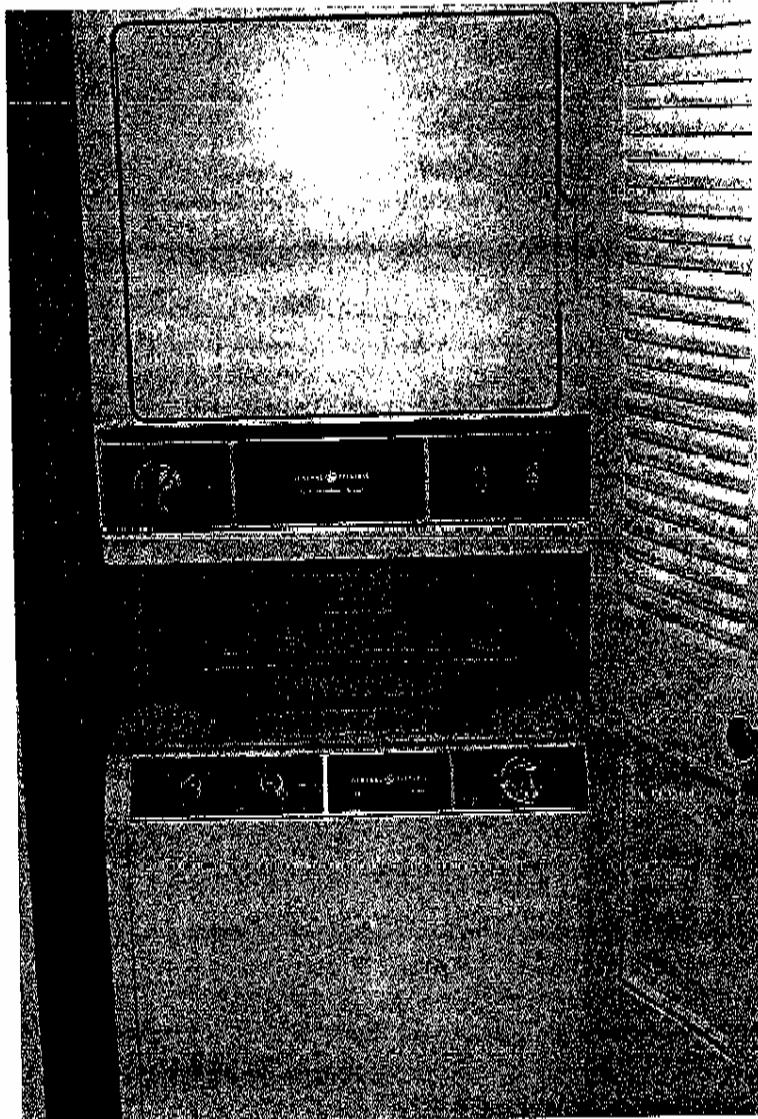
Laundry Room/ Hallway

- Acceptable : **Ceiling Type:** Drywall
- Acceptable : **Wall Type:** Drywall
- Acceptable : **Washer and Dryer** G E
- N/A : **Laundry**

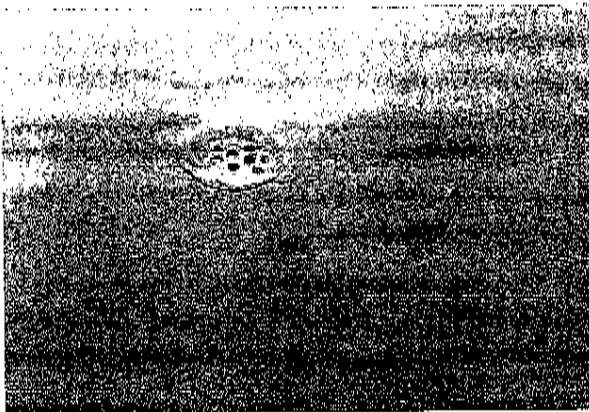
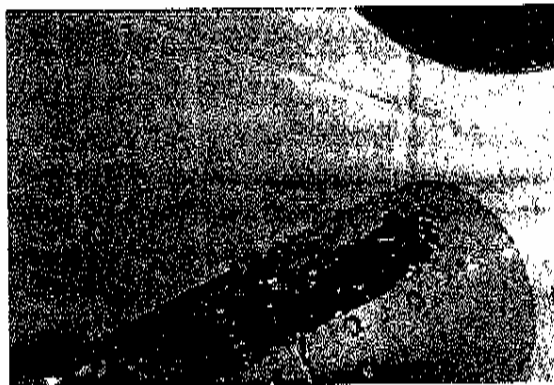
Bathroom #1

Marginal : **Ceiling Type:** Drywall ...Comments..> Signs of Water Intrusion In tub area
 Acceptable : **Wall Type:** Drywall/Ceramic Tile
 Acceptable : **Floor Covering:** Ceramic Tile
 Acceptable : **Lighting:**
 Acceptable : **Electric Outlets** Not GFCI
 Acceptable : **Toilet:**
 Acceptable : **Sink and Vanity:**
 Marginal : **Tub : Valve ...Comments..> Leaked**

Notes: There were signs of water intrusion at the ceiling. This is a moderate to serious issue. Water intrusion into the structure can lead to mold growth and other problems. Removing water-damaged materials for repair or replacement may reveal further damage and microbial growth. Recommend maintenance/repair by a licensed contractor
