# Allstate Home Inspections, Inc.

**Property**  
12345 Fisher Island Drive  
Bayside Village  
Miami, Florida 33109

**Report ID:**  
151115-1WF

**Inspection Date:**  
11/15/2015

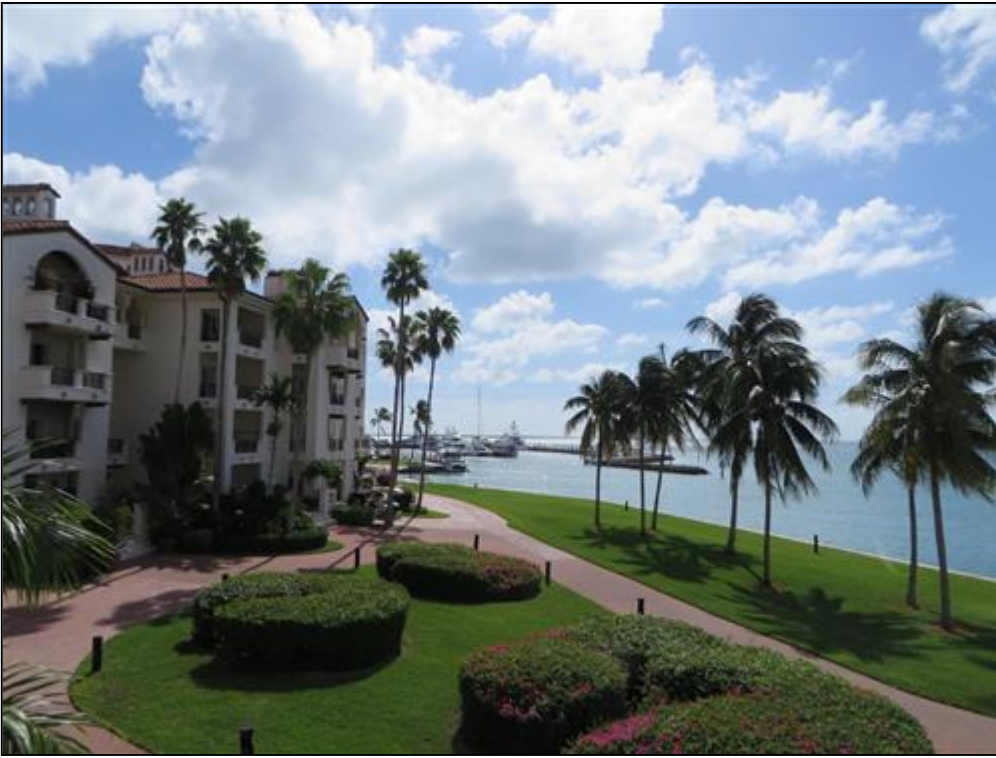
1.1.B Item 1(Picture)

**1.1.B** Complementary photos from your balcony.

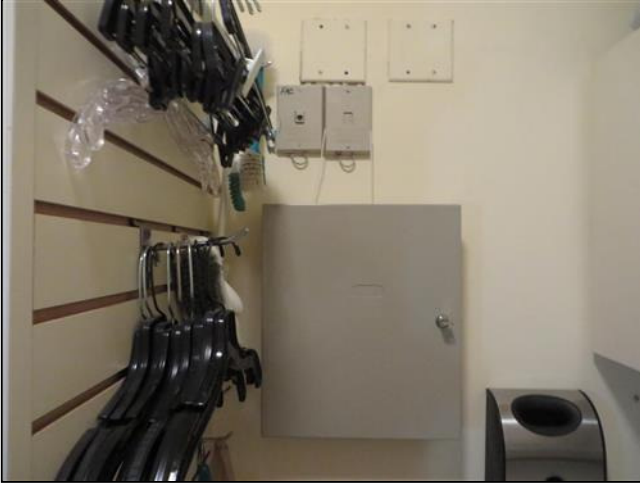
6.4 Item 1(Picture)

**6.4** Central smoke and fire, satellite, cable, internet, intercom, speakers or phone systems are not within the scope of this basic home inspection.
