Allstate Home Inspections, Inc.

Property
1234 Washingtonia Avenue
Townhouses By The Sea
Lauderdale by the Sea, Florida 33308

Report ID:
151115-2WF

Inspection Date:
11/15/2015

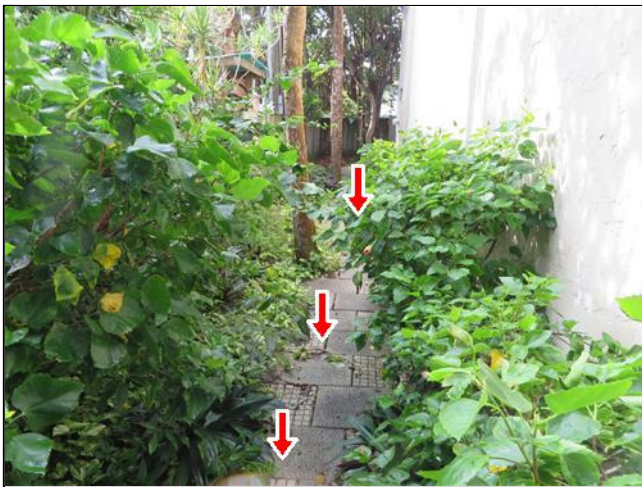
1.1 Item 2(Picture)

1.1 Pavers have uneven surfaces that may cause trip hazard (see photos), repair is recommend to prevent injury. Contact a licensed paver contractor or qualified handyman for all needed repairs.

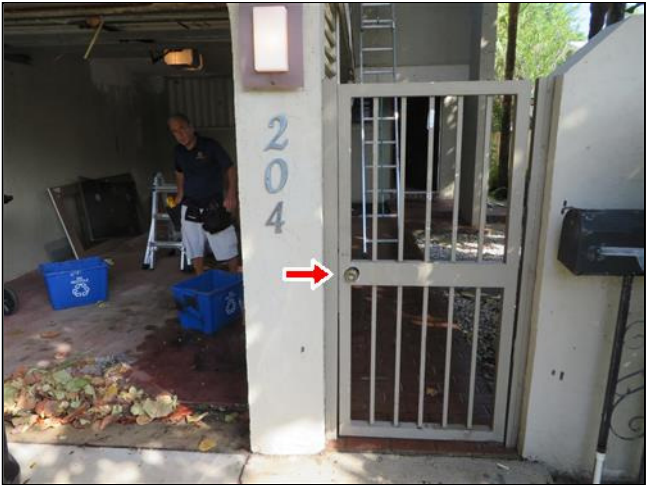
1.3 Item 2(Picture)

Gate's deadbolt lock is loose and non functional (see photo), adjustment and or repair is needed. We recommend contacting a qualified handyman for all needed repair.

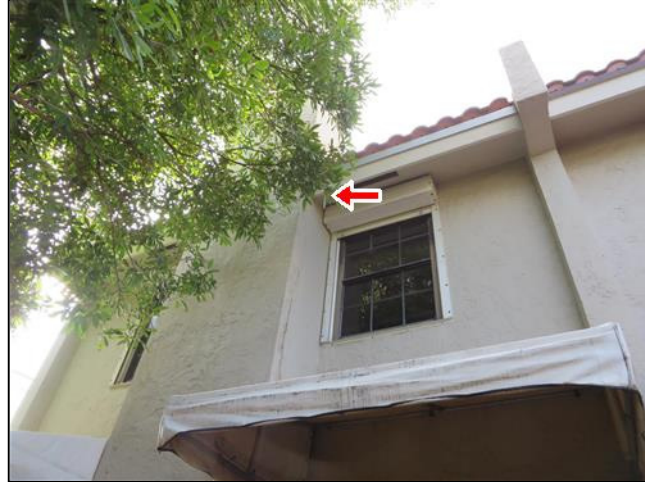
2.0 Item 2(Picture)

2.0 Fascia board has area with wood rot damage that needs repair (back of house near chimney, see photos). We recommend contacting a professional carpenter for further evaluation and all needed repair.

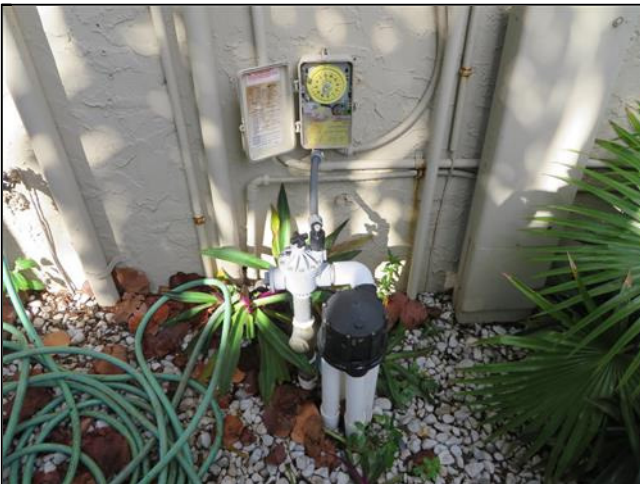
6.0 Item 1(Picture)

6.0 Inspector did not inspect sprinkler system, sprinkler heads or sprinkler timer . Sprinkler system is operated and maintained by homeowners association maintenance department.

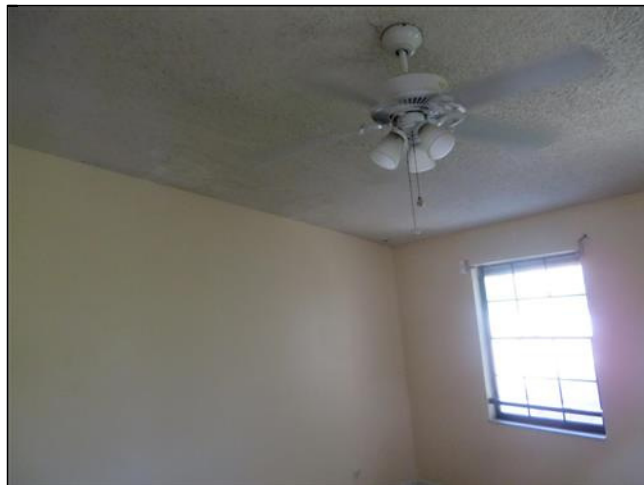
9.3.A Item 2(Picture)

Ceiling fan lights in the master bedroom were not working at time of inspection (see photo 2), we recommend changing the light bulbs first. If the lights are still not working, contact a licensed electrician for further evaluation and all needed repair.

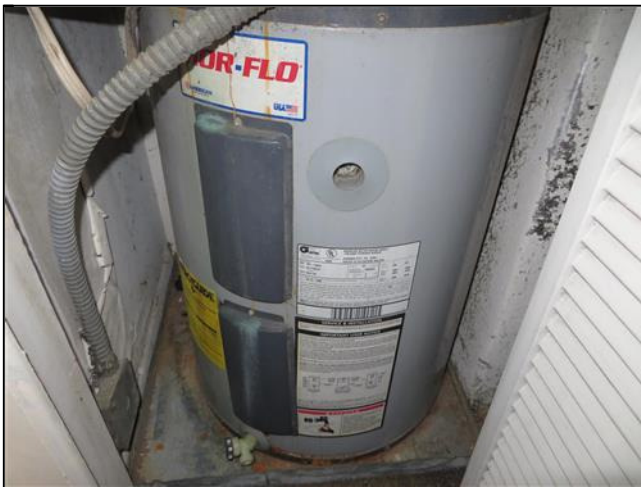
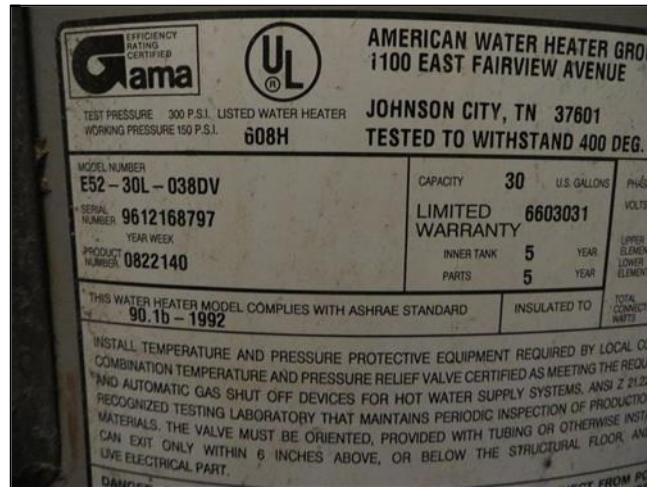
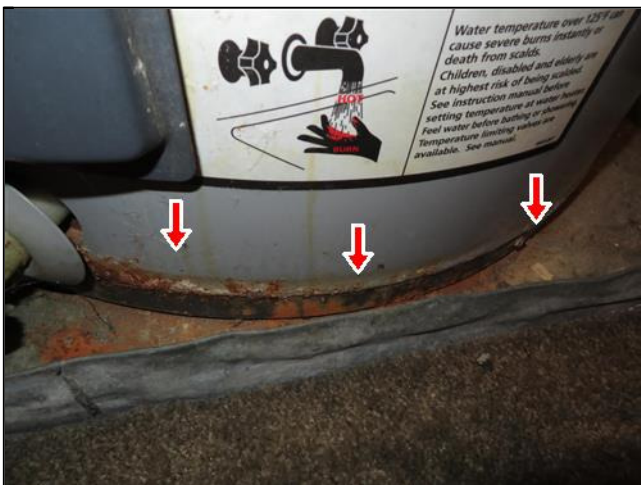
Base of the hot water tank at the hot water heater (see photo) has visible damage, corrosion and or rust. Base of the hot water tank **WAS NOT leaking** at time of inspection. We strongly recommend repairing or replacing hot water heater to prevent flooding. Contact a licensed plumber for further evaluation and all needed repairs.

NOTE: The State of Florida requires us to inform you of the typical life cycle or life expectancy of an electric hot water heater. Manufacturer's suggested life expectancy for an electric water heater is 13-15 years. This "age noted" hot water heater was functioning as intended and no visible defects were observed at time of inspection. Due to the age of this hot water heater, installing a new energy efficient water heater in the near future would reduce your energy cost and prevent possible leaks and or flooding. We recommend contacting a licensed plumber for further evaluation and replacement if needed.

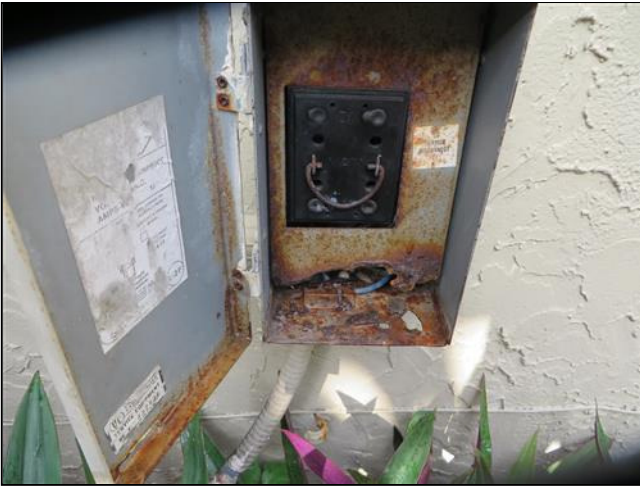
13.2 Item 1(Picture)

13.2 Air conditioners condenser's electrical disconnect box is damaged (corroded, see photo 1), repair is needed to prevent electrical shock. We recommend contacting a licensed air conditioning contractor for further evaluation and all needed repair

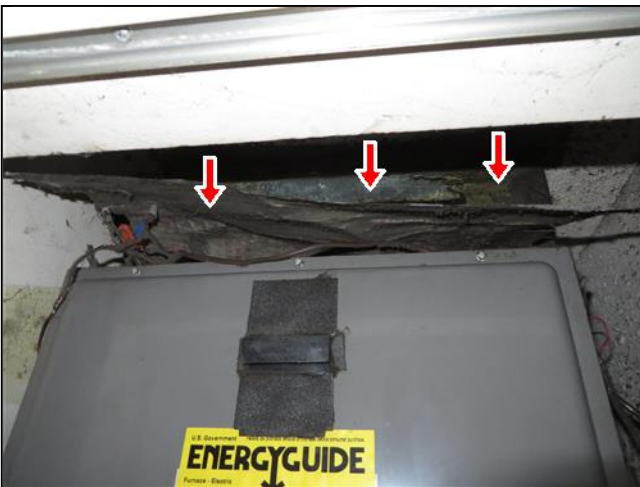
13.3 Item 1(Picture)

13.3 Air conditioning tape was failing or missing at air handler and or plenum (see photo 1), repair is needed. We recommend contacting a licensed air conditioning service contractor or qualified handyman for repair.

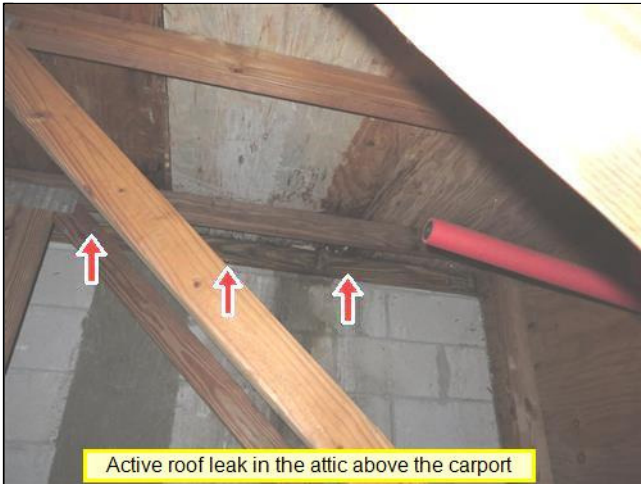
15.7 Item 1(Picture)

15.7 Water stains were observed on roof sheathing (above the carport, see photo 1) area was tested for moisture, **MOISTURE WAS** detected at time of inspection. We recommend contacting a licensed roofing contractor for further evaluation and all needed repair.

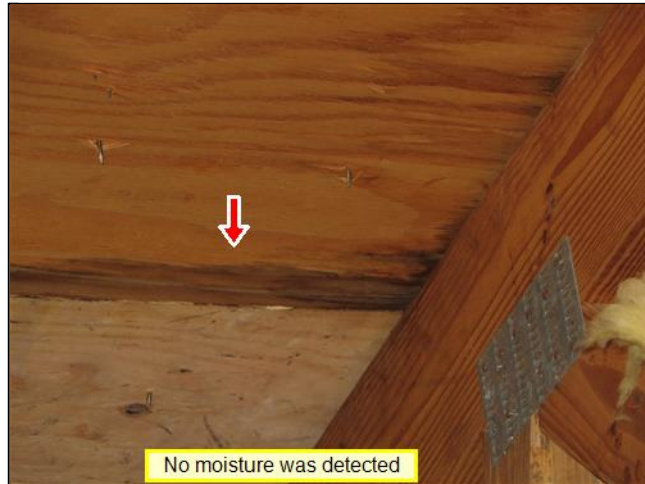
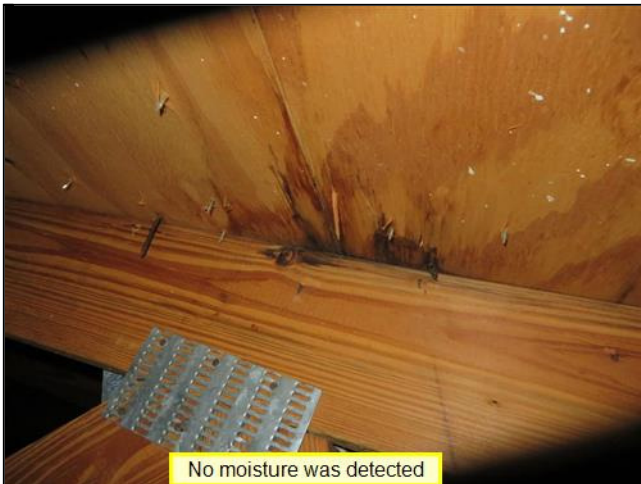
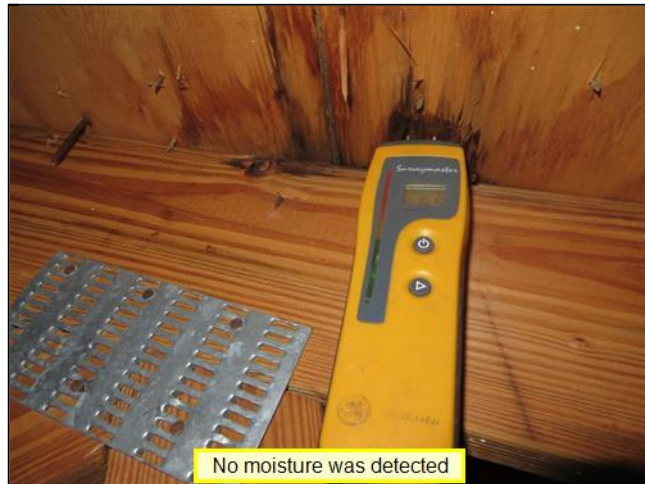
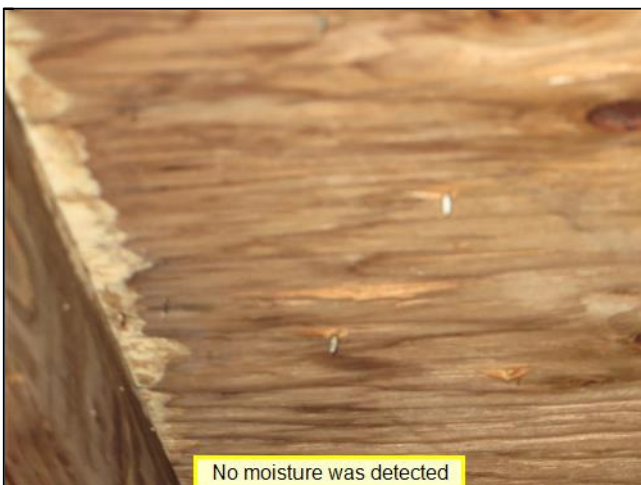
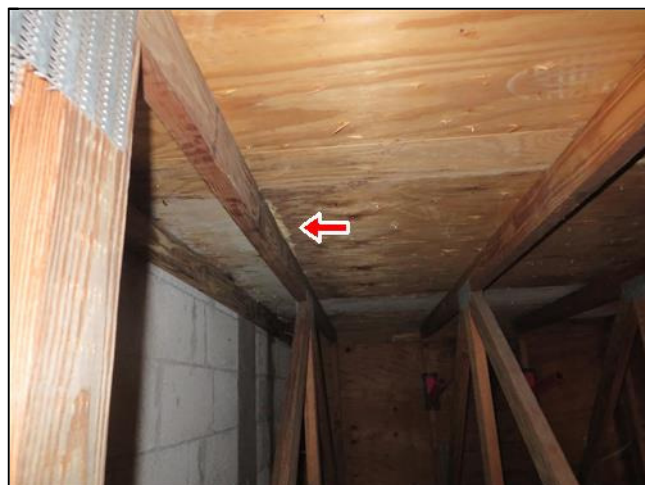
Water stains were observed in the attic (see photos 2 - 6), areas were tested for moisture with moisture monitor, **NO MOISTURE WAS DETECTED** at time of inspection. Staining appears to be from an old roof leak which seems to have been corrected. **We recommend that the buyer continue to monitor the stained area or areas and contact a licensed roofing contractor** if a stain appears to change color and/or a visible leak is observed.

Water stains were observed in the attic (see photos 2 - 6), areas were tested for moisture with moisture monitor, **NO MOISTURE WAS DETECTED** at time of inspection. Staining appears to be from an old roof leak which

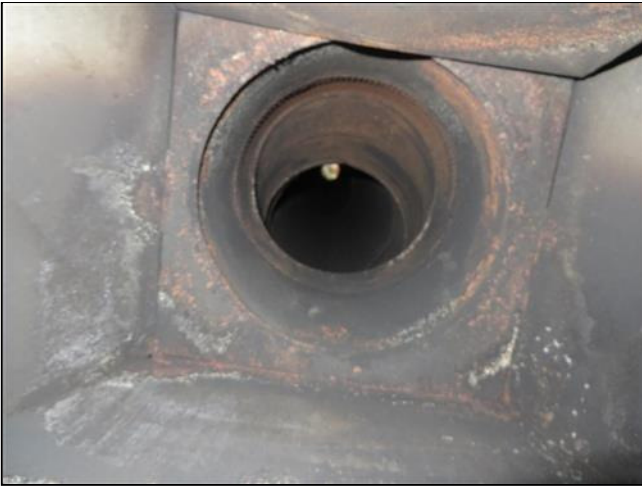
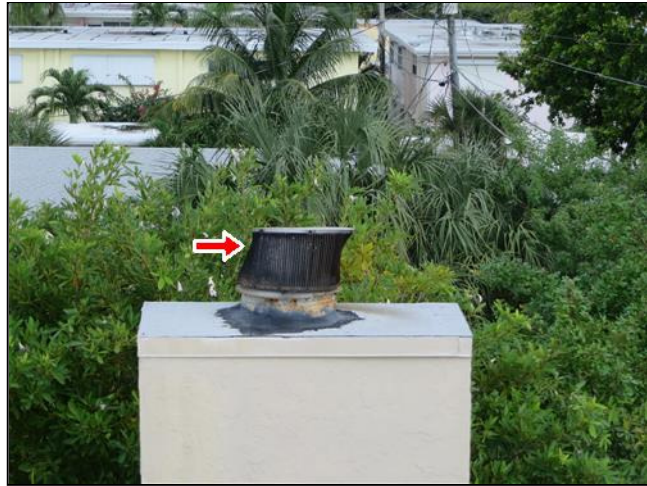
The top of the chimney (chimney cap, see photo) was damaged/dented, we recommend contacting a professional fireplace service contractor or a chimney sweep contractor for further evaluation and all needed repair.
